CORROSION OF BONDED ANCHORS IN CONCRETE

Jan Hofmann¹, Lisa Dambach¹, E. Cenk Köse²

¹ *Institute of Construction Materials, University of Stuttgart*

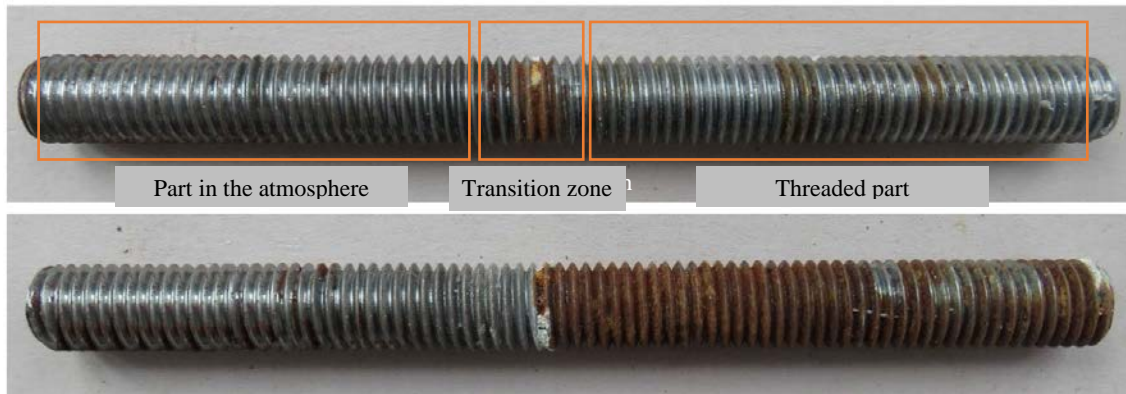
Fig. 2: Example for the visual assessment of the threaded rods (injection mortar made of 2-component resin) in the case of an offshore storage after 2 weeks (top) and 18 weeks (bottom) in artificial seawater

In the area of transition of the threaded rod, with the exception of the fixing concrete mortar, a moderate to strong red corrosion was observed in all cases. The reason for this is presumably the proximity to the water surface and the associated high humidity in the storage tanks. If the mortar has not completely sealed the borehole in this transition area, there will be strong or complete steel corrosion in this section.

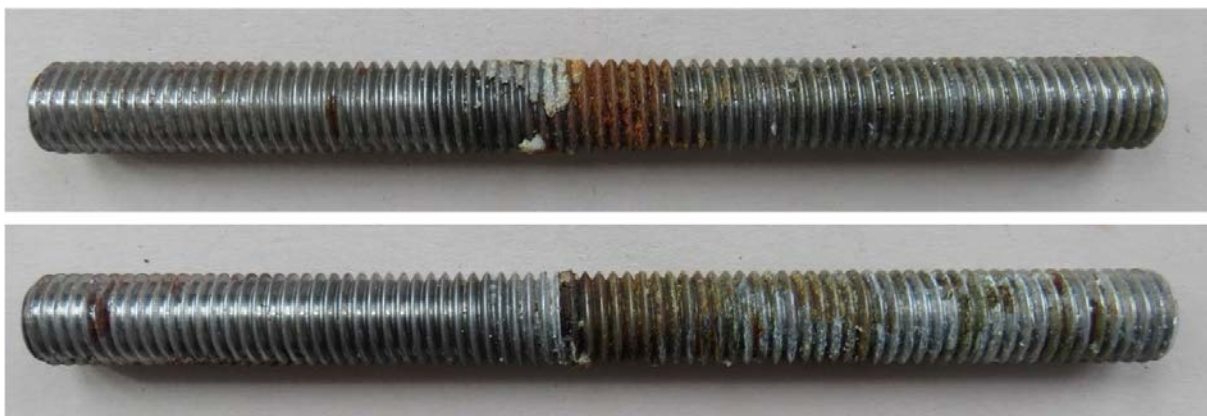
The investigations show very clearly that the steel corrosion only occurs in patches and is restricted locally. This can be shown very clearly in Fig. 3.

Fig. 3: Examples for the visual assessment of the threaded rods (vinyl ester based injection mortar) after 2 weeks (top) and 18 weeks (bottom) in artificial seawater

This observation suggests that chlorides could only penetrate at localized points and that the mortar had no protective effect in these areas.

Steel corrosion only occurs locally and is restricted locally. It can therefore be concluded that corrosion occurs in areas where the mortar has cracks or cavities. Since the protective effect of polymer-based injection mortars only exists because of their impermeability, a weak point in the mortar has a particularly negative impact in this case.

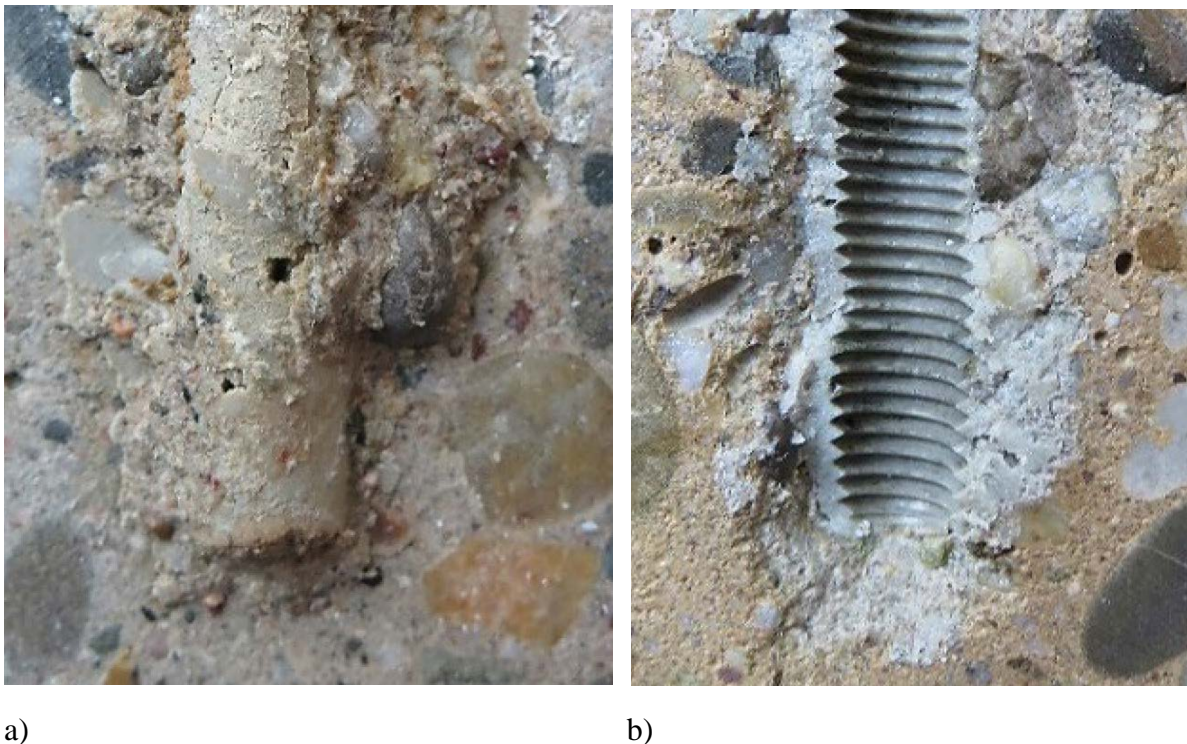
Fig. 4 shows a difference in the condition of the mortar. The vinyl ester based mortar, forms an uniform plane surface without any significant cracks or air bubbles. On the other hand, epoxy resin mortar shows a "brittle" structure. The mortar surface has considerably more cracks and pores. It cannot be determined with certainty whether these weak points are already present in the mortar before the concrete test specimens are could, for instance, be determined more precisely by means of X-ray investigations.

Fig. 4: Example for the optical evaluation of the mortar a) Epoxy resin mortar and b) Vinyl ester based mortar

In experiments the removal of mortar worked out easily with vinyl-ester and polyester based mortar because the structure was coherent. However, in case of epoxy resin mortar and mortar based on a 2-component resin, it was considerably more difficult to remove the mortar. Due to the "brittleness" of the mortar, only small fractions flake off when the mortar is being removed. The mineral mortar also has a "brittle" texture, but good adhesion to the surface. The complete removal of this mortar from the threaded rods is therefore not always possible. The investigations suggest that the more fragile and brittle the hardened mortar is, the

lower the protective effect against steel corrosion. However, this only applies to polymer-based mortars, since mineral mortars have an additional protective effect due to the high pH value and the ability to bind chlorides.

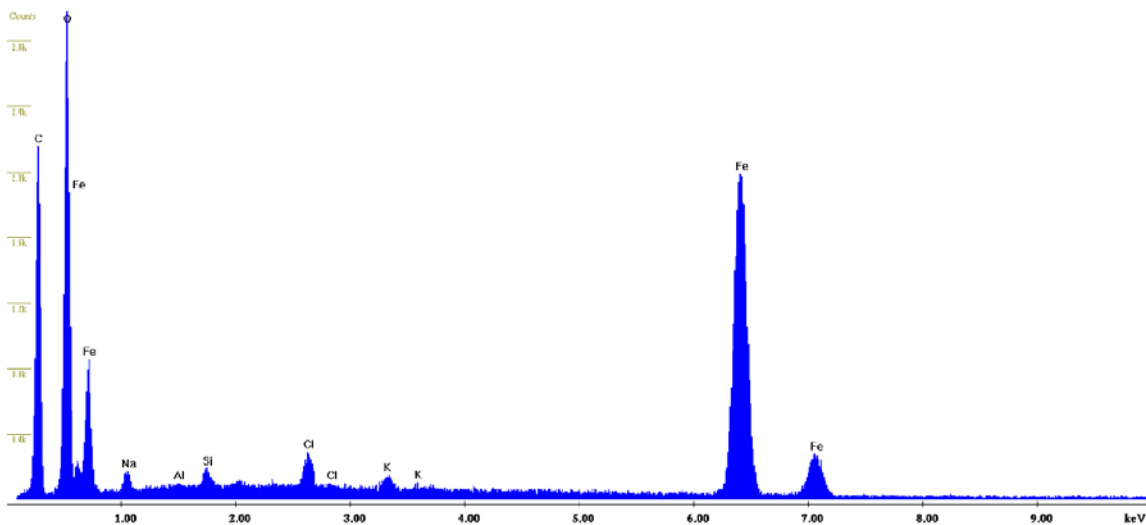
Fig. 5: EDX examination of a threaded rod which was installed with an epoxy resin based injection mortar and examined after 2 weeks of storage in artificial seawater

As shown in Fig. 5 chlorides were detected on the threaded rods installed with an epoxy based injection mortar, just after 2 weeks of exposure. A lower chloride value was observed with injection mortars made of 2-component resin or vinyl

ester. In the case of polyester based mortar, only minimal chloride values were observed (Table 2).
