CORROSION DAMAGES CAUSED BY CAST MAGNESITE FLOOR SCREED

Willibald Beul und Klaus Menzel

The use of cast magnesite floor screed demands special protective measures for steel and reinforced concrete because of the release of chloride. Considering a case of damage, the consequences of neglecting corrosion protection are demonstrated. Evolution of the damage is followed up for three years.

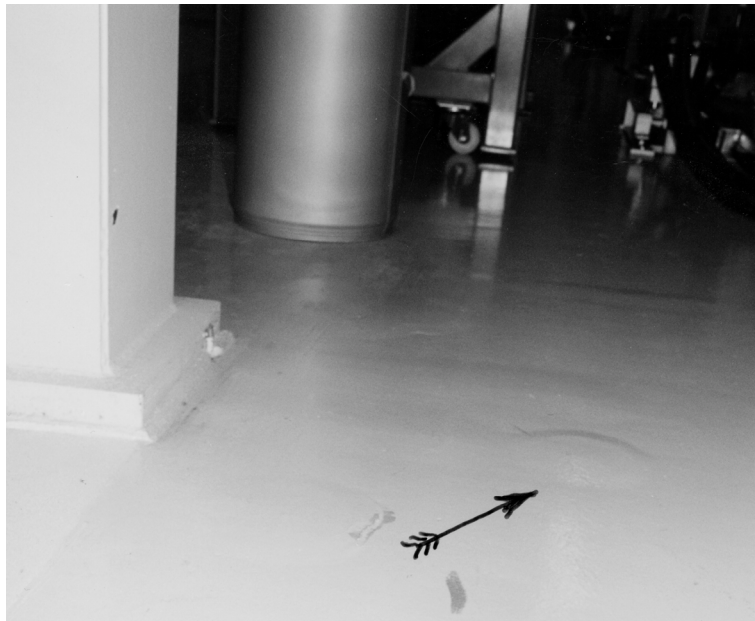
An industrial building, built in 1997 showed local bulging of the screed (ME 60 and ME 80) in the proximity of columns (fig. 1), where headed studs with relatively small concrete cover were cast in the floor slab. Since the damage arose systematically and was found exclusively within areas with magnesite screed, a connection with the screed works was assumed. The Otto-Graf-Institut was charged with the investigation of the damage.

Fig. 1: Bulges in the floor near column

bulged, hollow spots, where concrete was removed to a depth of 4 cm and replaced by a special repair mortar after cleaning the studs by means of sand-blasting.

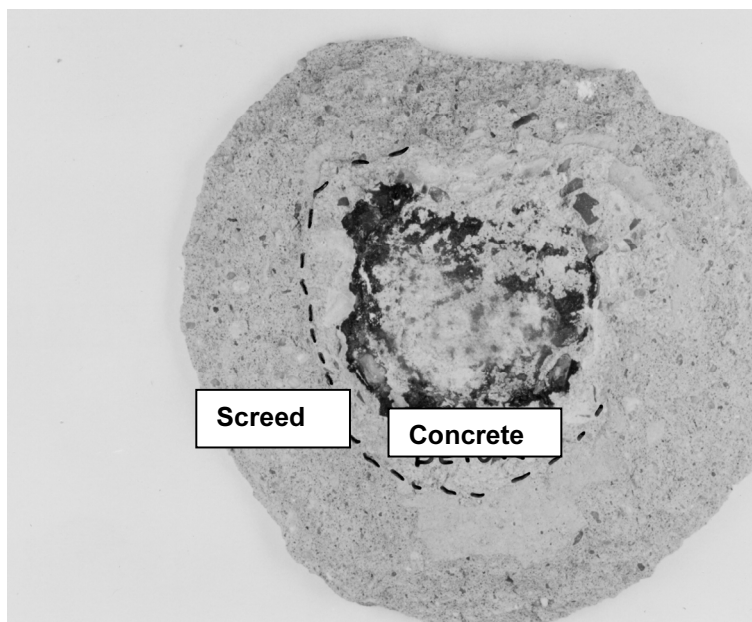
In a first visual investigation some of the bulged spots (diameter approx. 25 cm) were opened and examined. Bulging always started from headed studs with small concrete cover (< 2 cm), corroded on top (fig. 2).

Fig. 2: Bulge (bottom side) with rust stains from headed stud

The systematic uniformity of the apparent damage on all the areas covered with magnesite screed and the agreement of the chloride profiles in different places of the building permitted the conclusion that magnesium chloride solution had penetrated into the concrete and depassivated inserted steel with small concrete cover. The bulging and spalling was the effect of pressure, produced by corrosion products. The majority of the reinforcement of the floor slab did not seem concerned yet, as the results of potential measurements and the low chloride content in this depth (around 0,2 %) suggest.

The cause for the penetration of chloride was the absence of the barrier layer between magnesite screed and reinforced concrete according to DIN 18560 part of 3, table 2. The applied bonding layer was no barrier layer in the sense of DIN 18560.

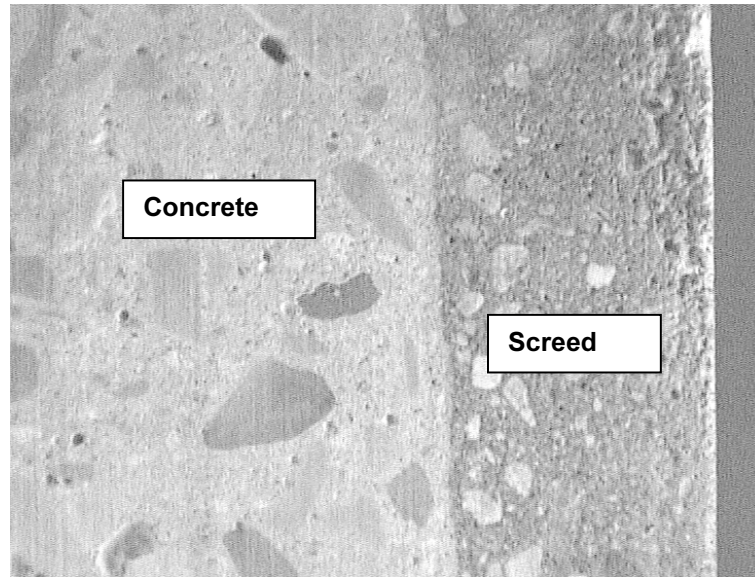
For further investigation 3 cores were drilled. At the boundary screed/concrete no apparently recognisable intermediate layer was found (fig. 3). The reinforcing steel with concrete cover of ≥ 4 cm was not yet corroded. From the drill cores samples were prepared for chloride analysis. The resulting chloride profile is given in fig. 4. In a depth of 2 cm (at the head of the studs) a chloride content of 0,3 to 0,9 % (related to cement weight) was found, in a depth of 4 cm (at the reinforcement) the concentration decreases to 0,15 to 0,2%.

Fig. 3: Drill core (no visible barrier layer)

Closer investigation of the boundary layer magnesite screed/concrete by means of differential thermal analysis (DTA) and thermogravimetry (TGA) showed that on the concrete an organic layer had been applied. However did the

chloride profiles point clearly to the absence of “sealing”- or “barrier”-characteristics of this layer.

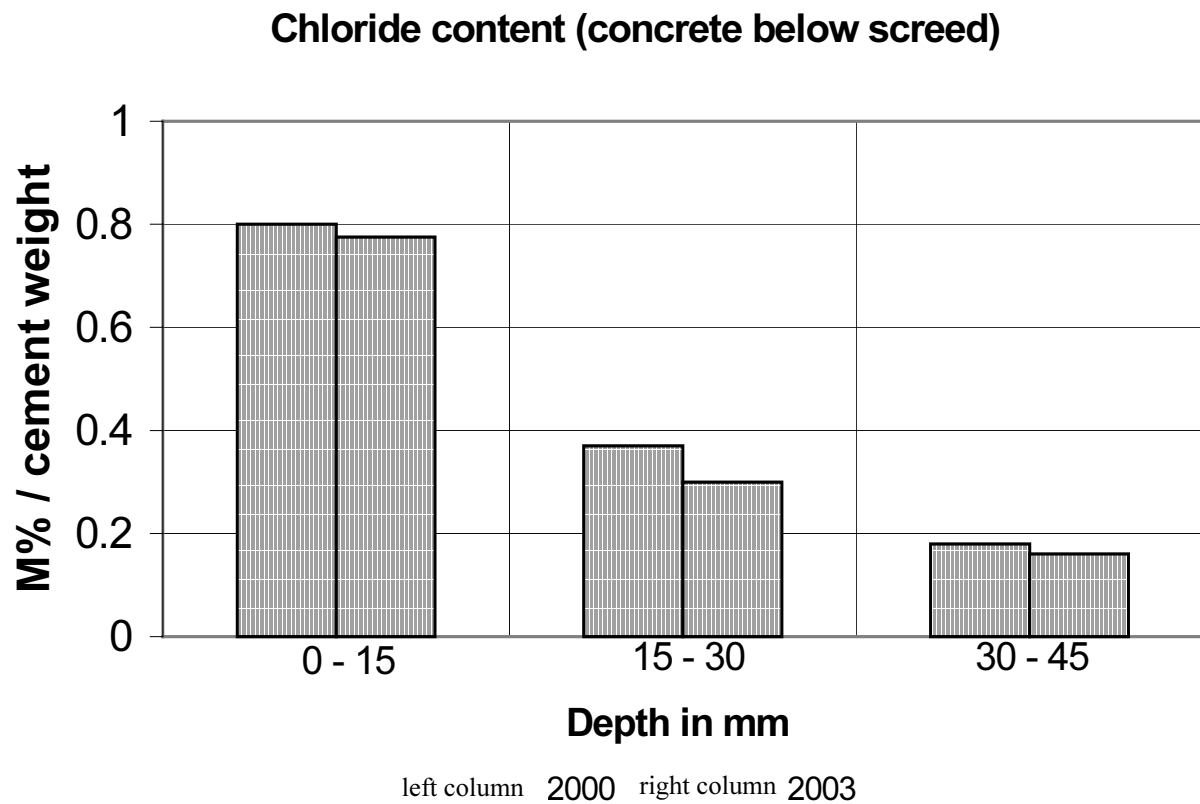
Fig. 4: Chloride profile in the years 2000 and 2003

At the time of the investigations a chloride profile with decreasing concentration was found. Critical chloride contents had to be assumed only in a depth less than 3 to 3,5 cm. In the course of time, due to the concentration gradient, chloride transport to deeper layers had to be expected. At the same time potentials were expected to increase (due to drying) and critical chloride contents to decrease (because of the higher potential). Chloride diffusion substantially depends on the water content of the concrete and on the kind of the cation. For magnesium chloride, diffusion coefficients three to four times higher than for the more usual sodium chloride were found in laboratory experiments [4].

Mean values for the chloride profiles 2000 and 2003 are given in fig.4. Unexpectedly, the concentration changes with time were found to be very small.

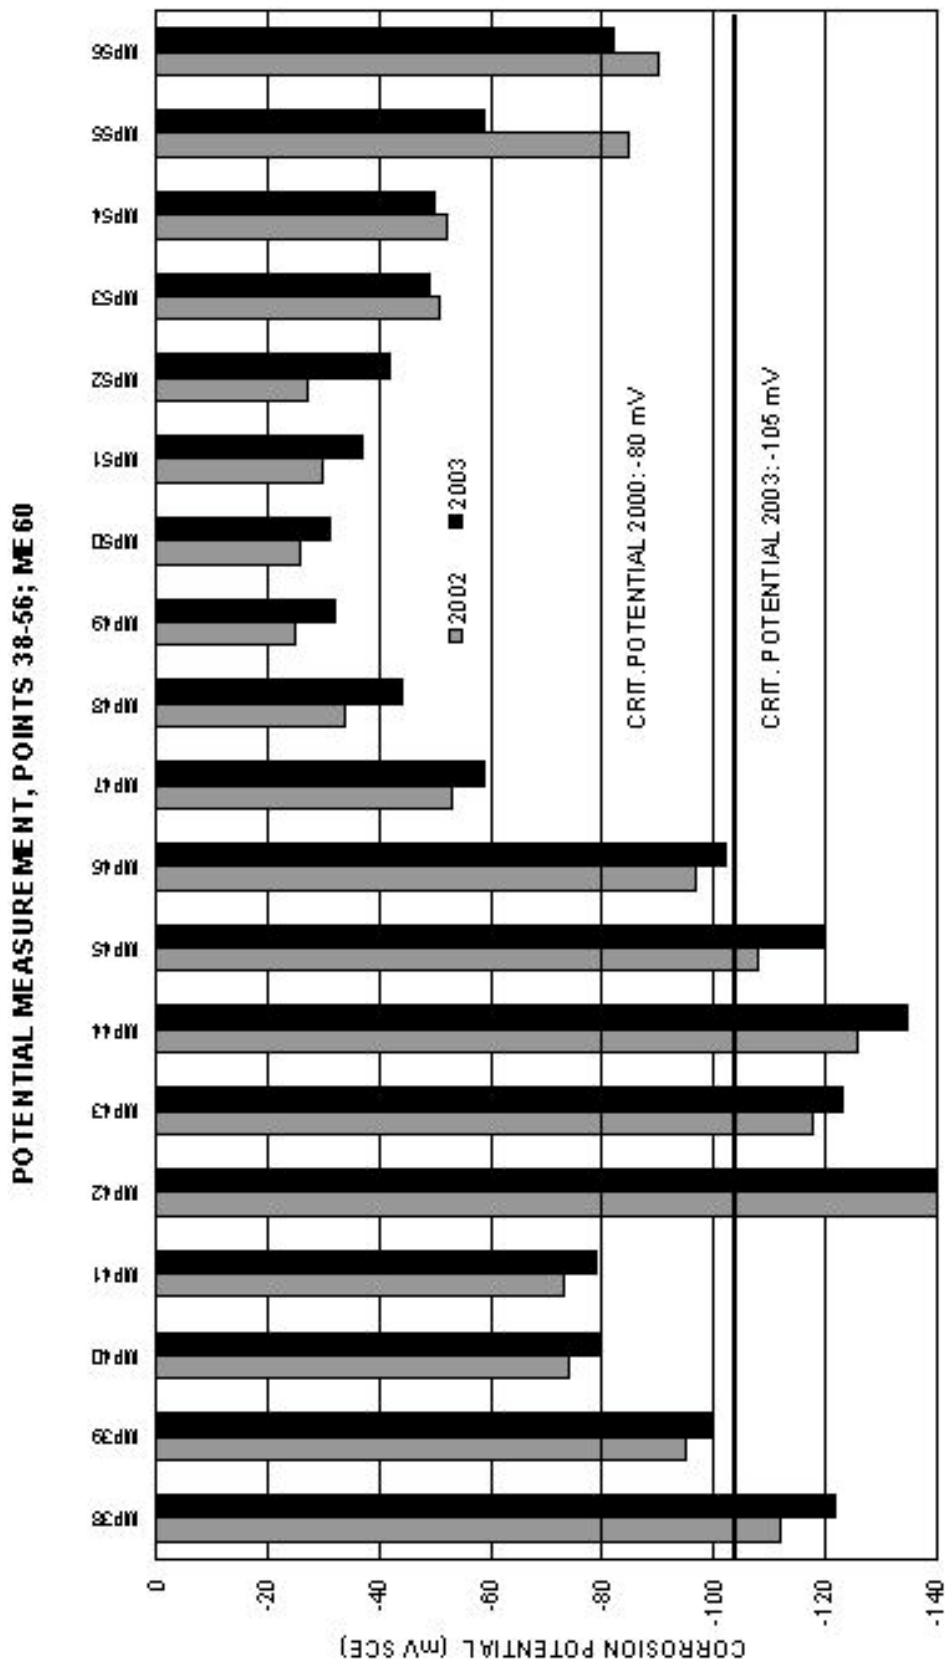
To detect early stages of corrosion, potential measurements were performed. The measurements resulted in potentials within a relatively narrow range from - 140 to - 50 mV against the saturated calomel electrode. Evaluation of the results by means of statistic methods [3] gave a critical potential value of - 80 mV.

In the years 2002 and 2003 the potential measurements were repeated at the same spots. Chloride profiles were also acquired again in 2003. At this time, additional bulging around six of the columns was found. Potentials are summarised in tab.1. An example of potential readings (2000 and 2003) is given in fig 5. The majority of potentials decreased in the course of time, but the critical value also was found to be lower by 25 mV. Anyway, active corrosion was still indicated at a remarkable number of measuring points, even in areas without headed studs.

Fig. 5: Example of Potential Readings 2000 and 2003
