THREE REMARKABLE CASES OF STRUCTURAL DAMAGE DUE TO IMPOSED DEFORMATION

Hans W. Reinhardt

Institute of Construction Materials, University of Stuttgart

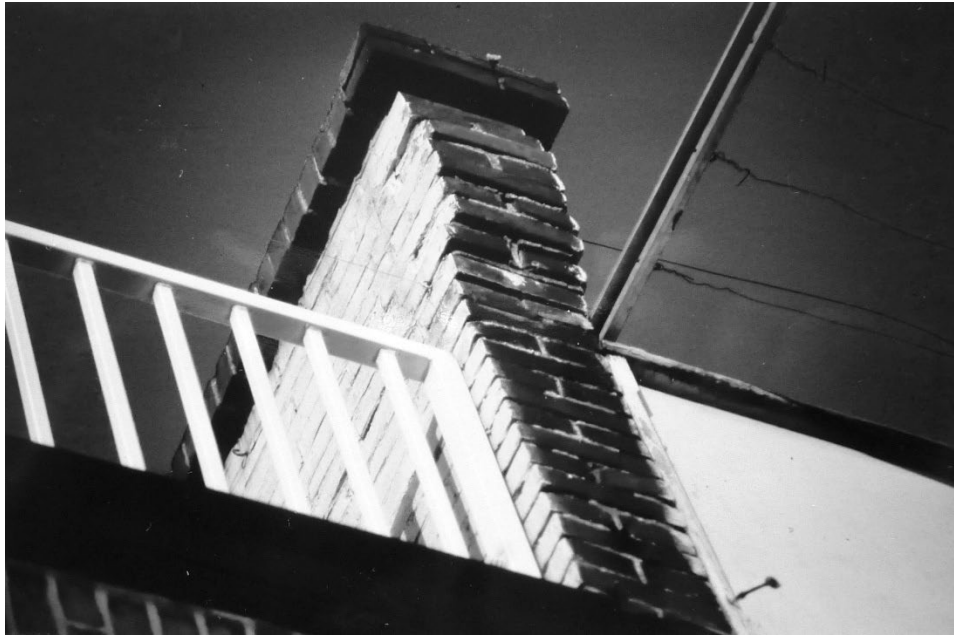
sun. Thermal expansion is highest at the top of the wall. Fig. 1 shows the permanent expansion as it appeared after about 70 years in service.

Fig. 1: Thermal permanent expansion of the partition wall

Cooling down means shortening of the wall. If the wall is homogeneous and uncracked it goes back into the original shape. What happens when the layers have different temperature and the hottest layer has slid on the base or on the layer underneath then friction will hamper the back movement and tensile forces develop. Since masonry has very little or almost no tensile strength cracks develop and a permanent elongation will occur. When the cracks are filled up with debris of the joints this permanent elongation is growing with each cycle. After many years the present wall has been grown half the breadth of the brick.

The wall has grown in the upper part more than in the lower. This can be due to the vertical load which is increasing towards the base. Higher normal stress means also larger friction which restricts the sliding movement of the brick layer during warming up, and the formation of cracks during the curing down phase also is improbable. Thus, warming up and down follows the temperature cycle but not synchronously. On the upper part of the wall, sliding of a brick layer is possible and the formation of cracks as well. Looking to Fig. 1 the largest deformation did not happen right on the top but some layers lower. Maybe the soldier bricks on top have reduced cracking or, when a number of parallel cracks separate an unreinforced slab or wall a package can develop by chance which obviously is the

case. Maybe the situation was aggravated by frost action and ice forming in the joints.

This example of imposed deformation does not immediately lead to structural problems but rather is a question of esthetics. No measures have been taken so far. When the whole town house is going to be renovated in the future the damaged wall will be replaced [1].

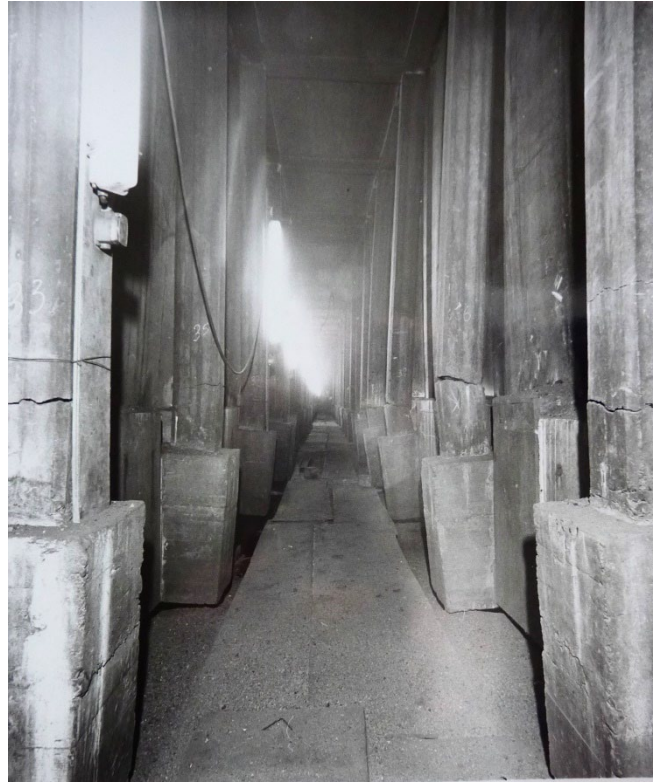
The furnace building covers two furnaces, a crane track and working platforms parallel to the furnaces. What happened? During the baking process which takes about 3 days (warming up, holding the temperature, cooling down) the concrete box is warmed up to a mean temperature of about 100°C and dilates. Normal to the outer wall, the partition cross-walls made of fireproof bricks are heated up to about 1,000°C and dilate much more. They are rather stiff and push on the thermal insulation of the concrete walls and compress it. During cooling down to bearable working temperature, the thermal expansion goes back, but not completely. Cracks in the masonry are formed and partly filled up with pitch and coke. This happens every cycle with the consequence that the cross-walls grow more and more, compress the insulation and push on the concrete wall of the furnace. Shear forces develop in the lower part and bending forces in the whole side wall.

Fig. 4 shows the situation on a picture taken in longitudinal direction between the two furnace boxes. The bottom of the furnace has become larger and has pushed on the reinforced columns which support the working platform. The columns were only slightly reinforced and became severely cracked. The platforms got normal forces and transmitted them to the outer columns which carry the bearings of the columns of the roof and the crane track. One was afraid that the crane could be derailed and collapsed. A look to Fig. 5 unveils the width of the main crack and the minimal reinforcement.

Fig. 4: Deformed concrete box and cracked columns (from [3])

What measures have been taken? First, to check the stability of the structure, it has been converted to a computer model taking account of the deformation and the cracks. Second, the structure has been analyzed again. (It was not easy to convince the engineers of the owner that the problem was a deformation problem and not a force problem.) From the calculation, it came out that the structure was still stable, but it was advised to shore the outer walls of the furnace and to monitor the state regularly.

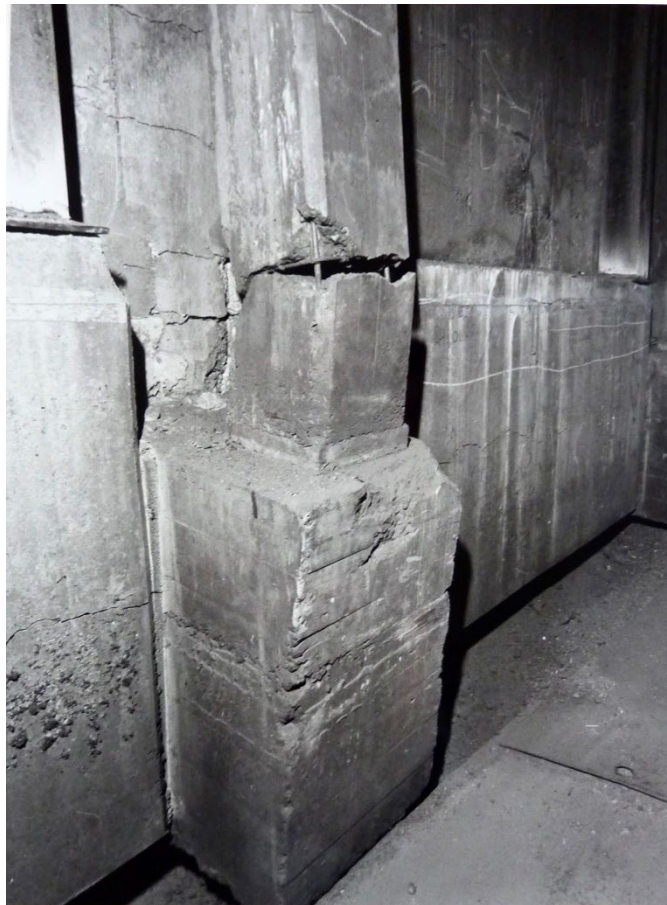
Fig. 5: Column with large crack, showing the small reinforcement (from [3])

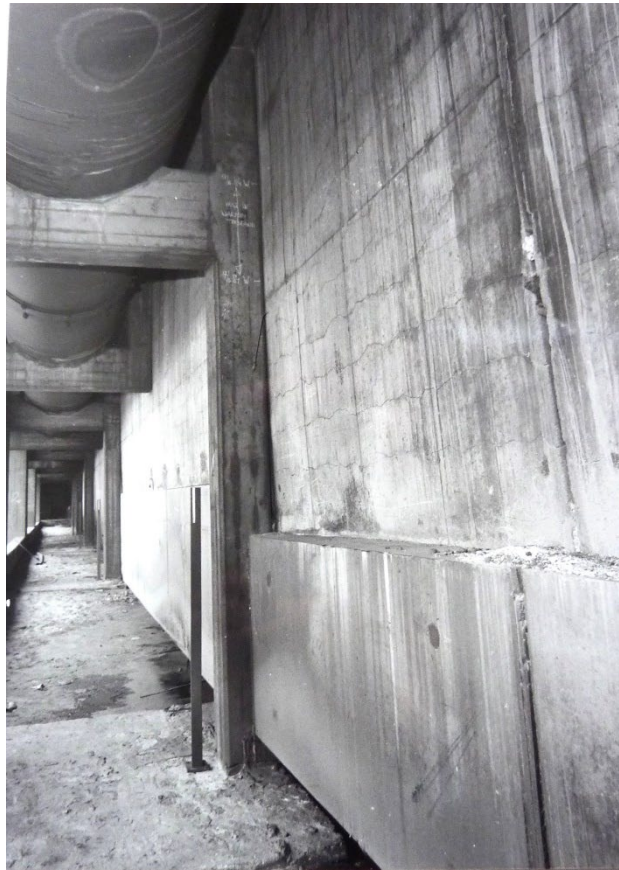
Fig. 6 shows the outer side wall of the furnace which is bent and cracked in a regular pattern.

Fig. 6: Outer side wall of the furnace (from [3])

The wall is leaning against the columns of the working platform. The lower part of the wall has been repaired by adding a reinforced concrete supplement in order to increase the shear resistance of the wall. On the right side of the picture one can see a dilatation joint of the furnace.

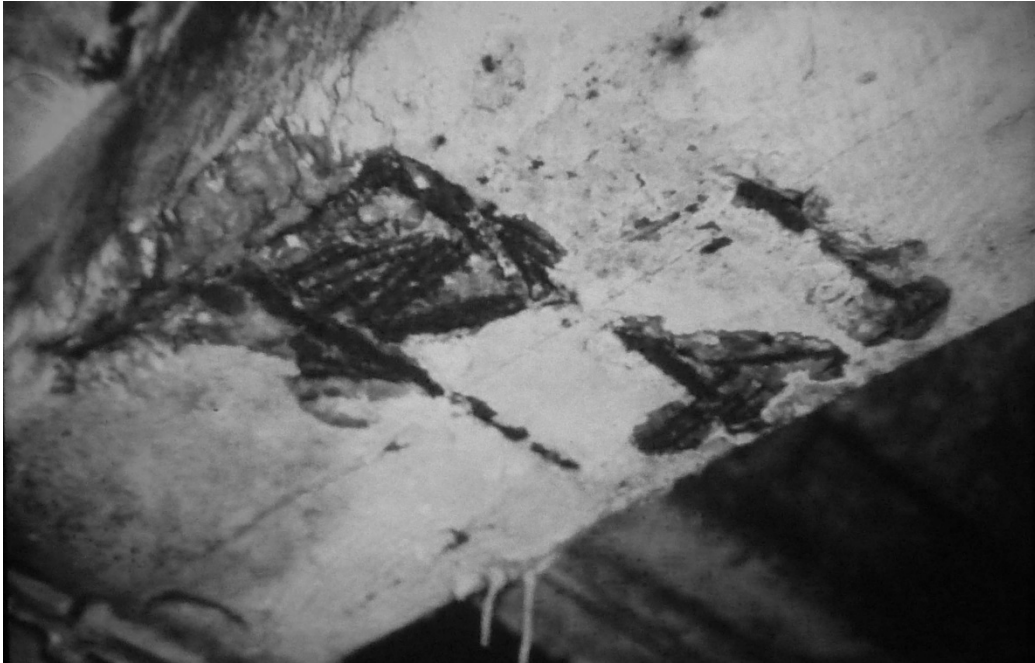
Another possibility was that some assumptions in the static analysis were wrong. A check of the calculations showed indeed that creep and shrinkage were not considered. The structure was older than the date of introducing creep and shrinkage into the standard. After checking the calculation with the phenomenon creep and shrinkage it turned out that this could have been the reason for transverse cracking. The background deliberations can be found in [5]. (A simplified approach: If the tensile force in the lower chord is equal to the prestressing force, the concrete is stress-free. If, additionally, creep has reduced the initial prestressing force then the concrete can get tensile stresses and cracking may occur.)

The lower chord is an almost pure tensile member on which transverse cracks have been found. They have been discovered when large rust stains could be seen, Fig. 9.

Fig. 9: Corrosion products on lower side of tension chord

The stains follow cracks of destroyed concrete cover which are caused by corrosion of stirrups. The rust was a token that the girder should be observed more carefully since the hall served a business with large damp production.

The measures taken were regular inspection and continual observation.

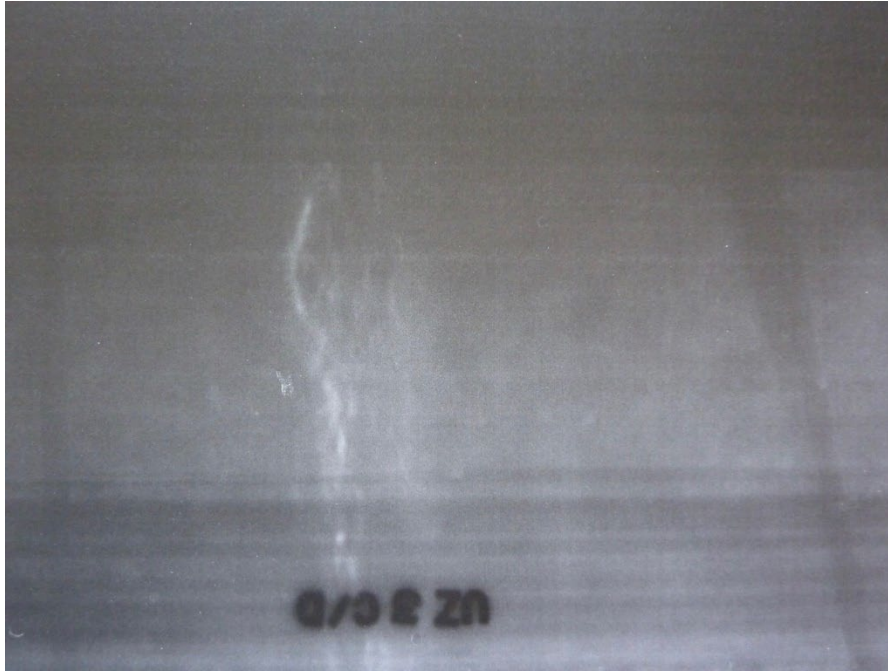
The following Fig. 10 gives an impression. On the figure one can see at the very bottom dark lines which represent steel. Further vertical dark lines represent stirrups.

Fig. 10: Dark lines on bottom of the chord indicating prestressing and reinforcing steel, vertical dark line caused by stirrup, bright lines due to cracks in concrete

According to the original static analysis which was still available thin prestressing wires were used what was confirmed. Fig. 10 gives additional information by the vertical bright lines which represent cracking. Of course, several pictures were taken which is necessary for a thorough inspection. However, they did not give any other information.
