ALKALI-SILICA REACTION (ASR) ON GERMAN MOTORWAYS: AN OVERVIEW

Oliver Mielich

Materials Testing Institute (MPA), University of Stuttgart, Otto-Graf-Institute

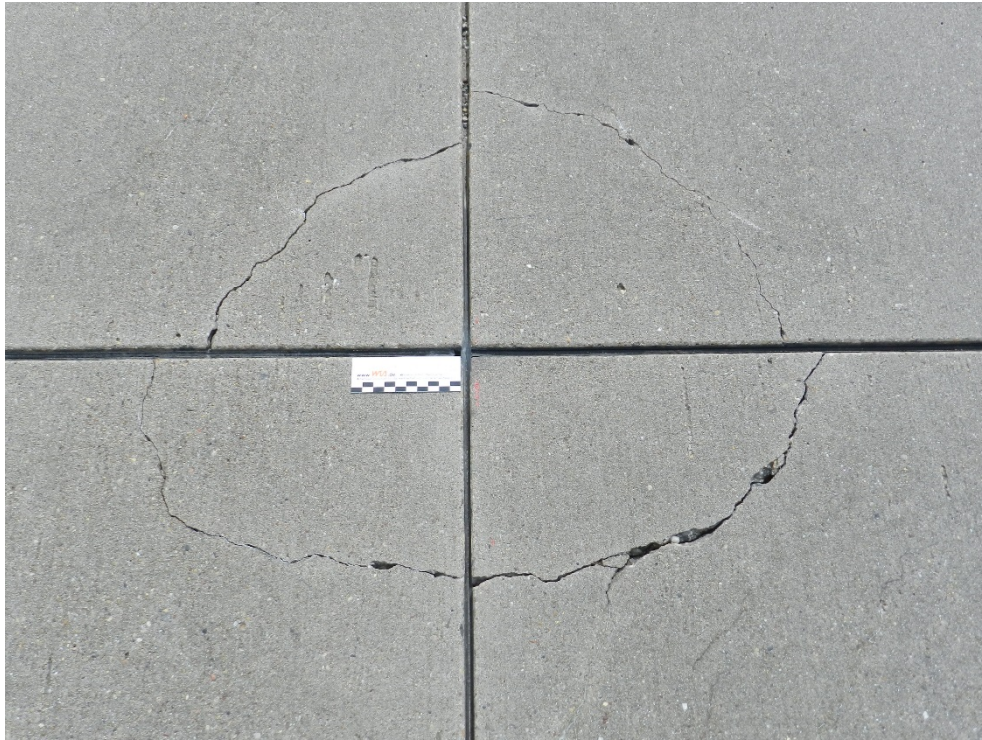
Fig. 1: Corner fracture

When assessing ASR-specific damage characteristics, [23] takes the construction of concrete pavements (one concrete mixture/single-layer constructed, one concrete mixture/double-layer constructed, two concrete mixtures/double-layer constructed) into account. Accordingly, in a two-layer construction with an alkali-insensitive top layer and an alkali-sensitive bottom layer, the known discolorations in the transverse and longitudinal joints are not the first signs of an ASR. The first signs in this case are corner fractures of an ASR (Fig. 1). The cause of corner fractures can be found in a horizontal crack in the concrete itself (Fig. 2). In addition, longitudinal cracks on the concrete surface caused by ASR-induced stress build-up in the bottom concrete can also be the result. Even in two-layer constructions, in which the ASR-induced reaction takes place faster in the bottom concrete than in the upper concrete (upper concrete also sensitive to alkali), the discolorations do not indicate incipient ASR, but rather corner fractures and longitudinal cracks [23]. The cause of corner fractures and longitudinal cracks must always be determined. As described in [23] for example, corner fractures can also be caused if there are no frost-proof and erosion-resistant or compaction defects in the sub-base layer. However, both causes play only a minor role [24]. A further possibility are changes in the sub-base layer due to insufficient drainage. First, surface water reaches the sub-base layer through damaged joints that cannot be effectively drained away. The base then decomposes and loosens under traffic

stress. As a result, the slab lies hollow at the water penetration point and later breaks due to overload [24].

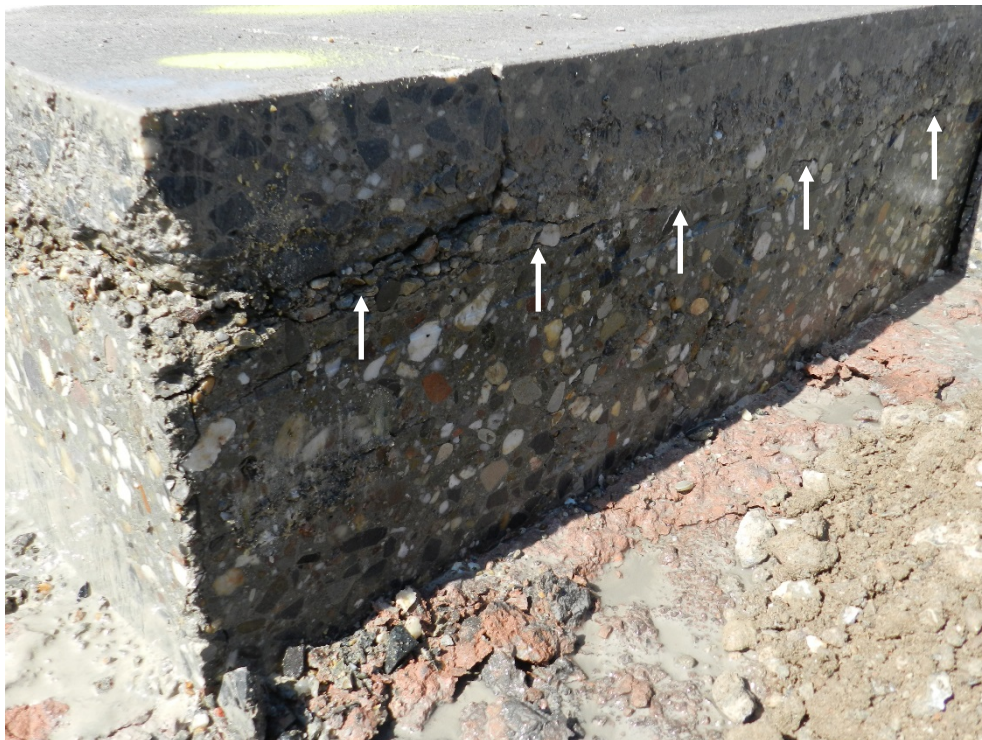
Fig. 2: Horizontal cracks related to corner fracture in Fig. 1
