TESTS ON REPRODUCED BYZANTINE MASONRY

Holger Falter, Hans-Wolf Reinhardt

KEYWORDS: ancient masonry, testing, strength, deformation, Byzantine church, San Vitale

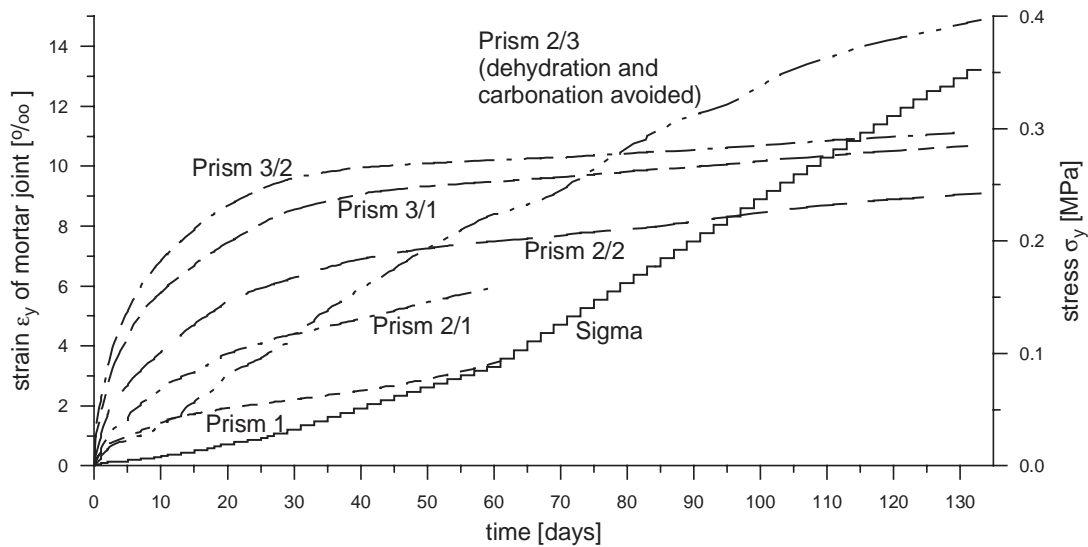
The results of the incremental loading are summarized in Fig. 2. The horizontal axis shows the time from beginning of loading. The left vertical axis shows the strain with respect to the joints, i. e. it is assumed that the brick deformation is negligible with respect to the deformation of the joints. The right vertical axis shows the stress which increases incrementally. It can be seen that the strain increases very fast in the first 20 days despite the rather small stress. Prisms 3/2 and 3/1 deform most because the joint is thicker than of prisms 2/1 and 2/2 and 1.

Fig. 2: *Stress vs. time and strain vs. time relation of incremental loading*

Since prism 2/3 is lacking behind prisms 2/1 and 2/2 it should be assumed that drying shrinkage plays a major part in the deformation during the first 20 days. When stress increases, the joints of prism 2/3 are still water saturated and deformation increases more than that of prism 1, 2/1, 2/2, 3/1 and 3/2. The stress-strain behaviour of the mortar in the joint is the effect of various phenomena: compaction due to water absorption of the bricks, consolidation due to seepage of water, shrinkage due to drying, carbonation, plastic deformation in the fresh state, elastic deformation, and viscous creep in the early age and later on. It is really a complex behaviour which has to be studied more carefully in the future.
