LANDSLIDES AND ROCKFALL IN KEUPER

Geoffrey Gay, Herman Schad

KEYWORDS: Mudstone, weathering, landslides, rockfall, softening, shear parameter

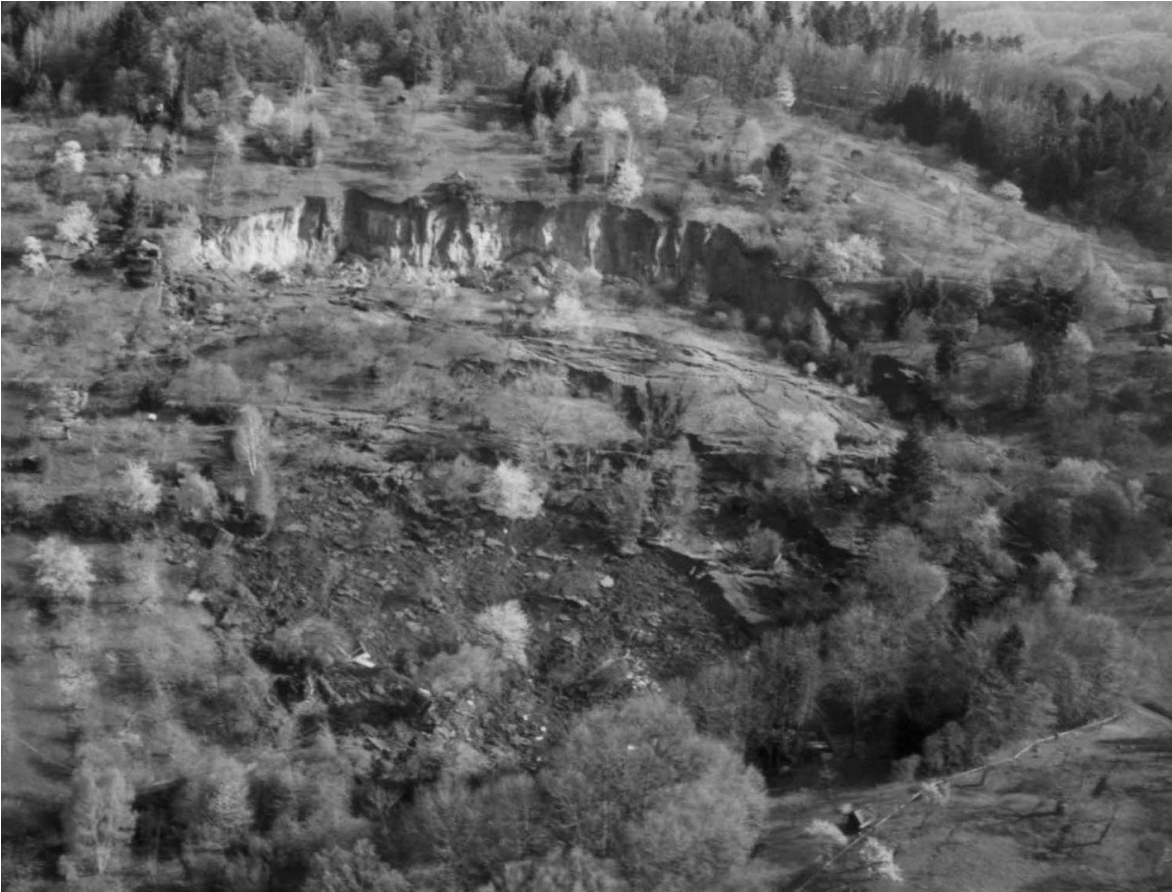
Fig. 2: Aerial photograph of landslide at Urbach

On the 7th April 2001 a landslide occurred in Urbach (30 km west of Stuttgart, see fig. 1). The area affected was about 3.2 ha. and it is estimated that about 500m³ of soil and rock were involved in the slip. After the slip a rock wall about 15m high and 150m long was left standing at the head of the slip. A good view of the slip and the surrounding area is shown in fig. 2.

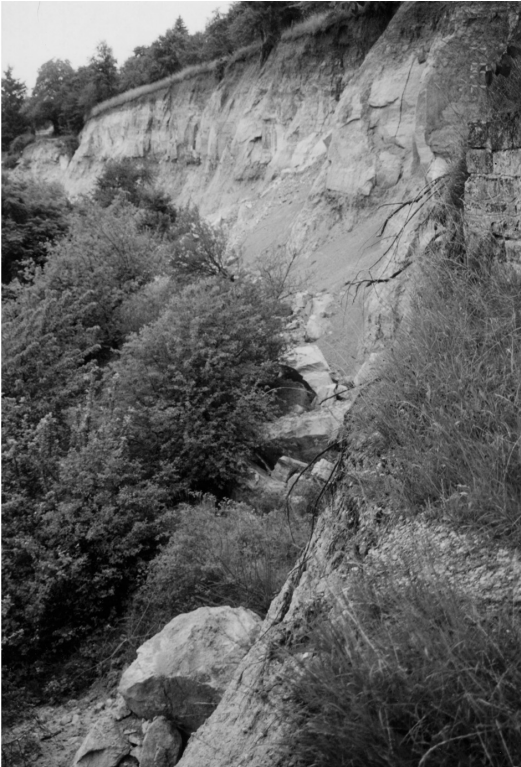
Fig. 3: Detail photographs of landslide at Urbach

At the head of the slip where the ragstone is present the movements resemble a rock fall whereas at the toe of the slip it was more a creep and slip movement. (see fig. 3).

Northern boundary of urbach

View in direction Urbach

Rock wall in ragstone

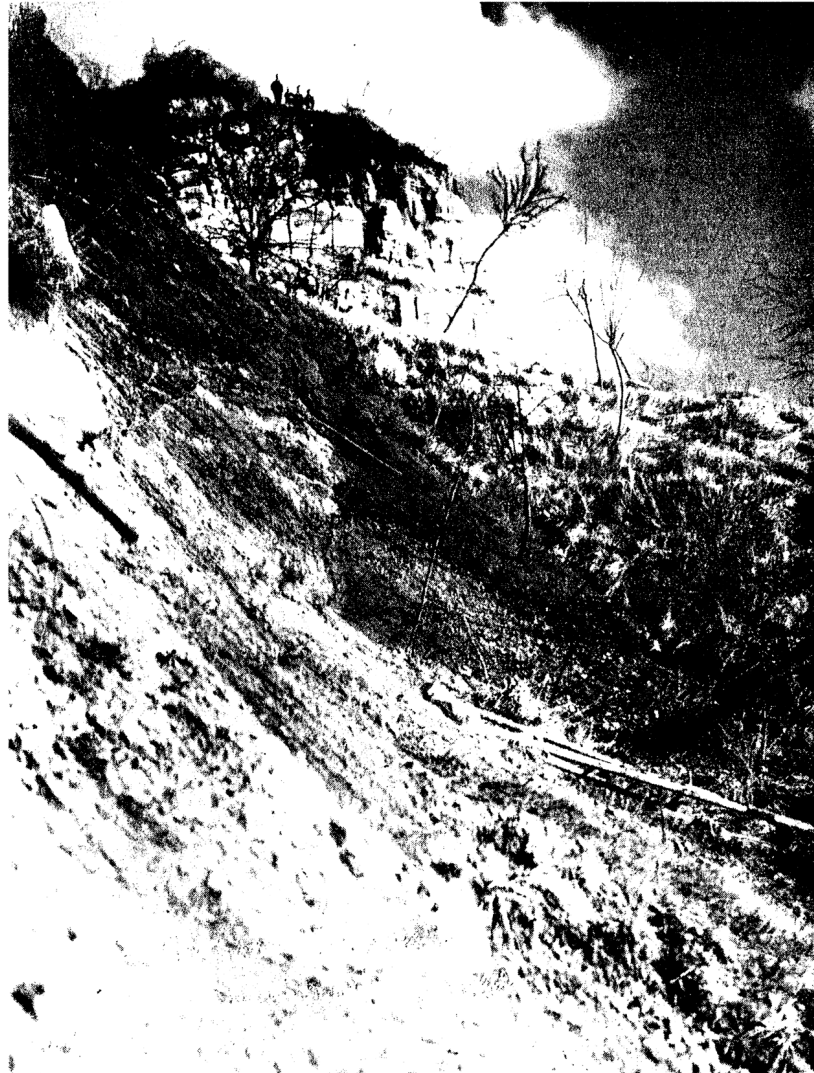
Fig. 6: Pictures of the slip on the Alten Berg

About 700m south of the slip which occurred in April 2001 a slip took place on the Alten Berg in the nineteen twenties. This slip was much bigger than the present one and was a danger for the village of Urbach. The state of the slip in 1923 is shown in fig. 6.

Bergsturz bei Ober-Urbach bei Schorndorf in den Bunten Mergeln. Februar 1926.
Blöcke = Kiesel sandstein. Phot. A. HÜTTER.

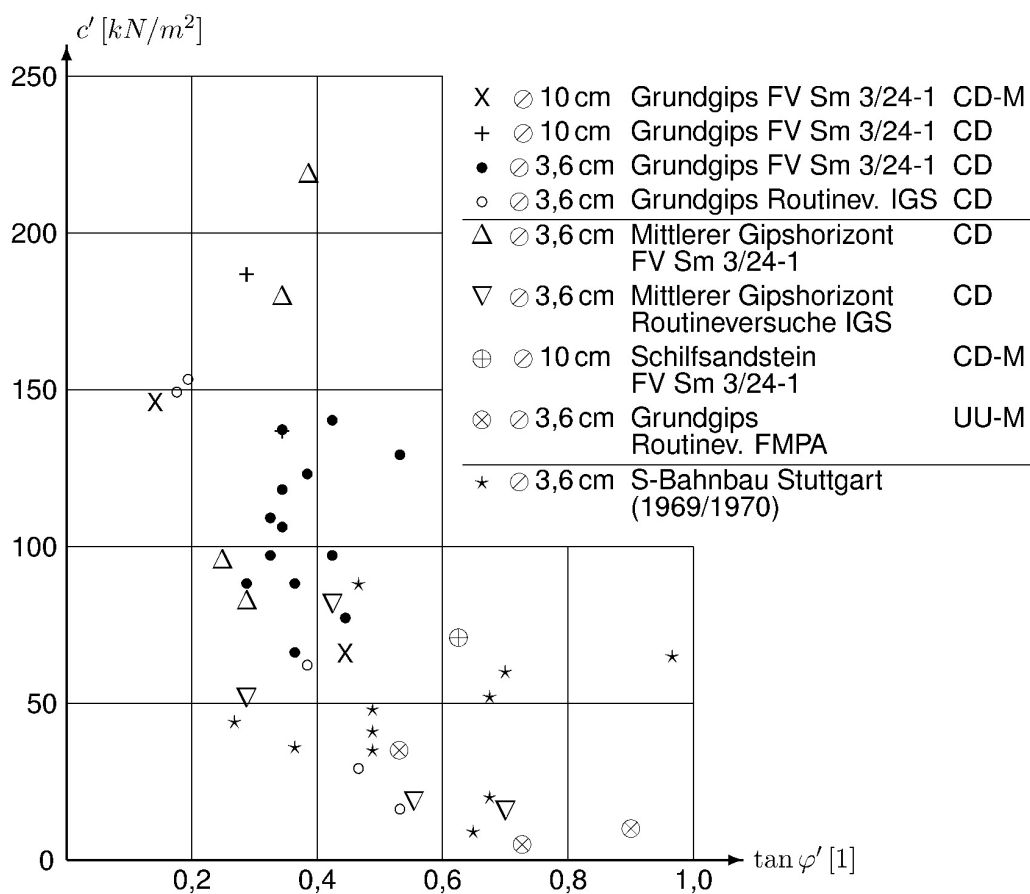
Fig. 8: Results of 45 triaxial test on weathered clay stone with $0.8 < I_c < 1.0$ (mainly gypsum marl from Stuttgart)

From the many laboratory test carried out during the building of the underground railway in Stuttgart during the seventies and also from a DFG research programme (Smolczyk et al.1985) there were 45 tests with consistencies between 0.8 and 1.0 which could be evaluated. The results are shown in figs. 8 to 10.
