EXPERIMENTAL IDENTIFICATION OF THE GRADE OF PRESTRESSING OF A REINFORCED CONCRETE SLAB WITH UNBONDED PRESTRESSING

Thomas Jahn

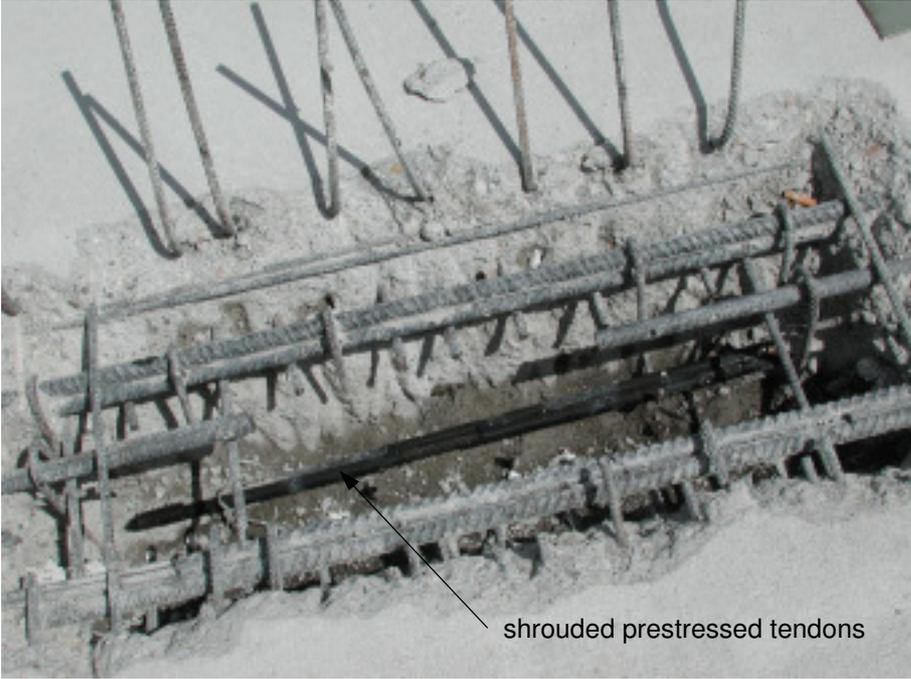
Fig. 4: stemmed surface of the slab in the area of tendons (axis 204)

- The upper surface of the concrete slab was stemmed at a length of 1,2 m (in the axis 204, 229 and 256 of the building) and the tendons were uncovered, see fig. 4.

Because of unexpected deformations in a prestressed reinforced concrete slab (unbonded prestressing) it was necessary to determine the existent grade of prestressing by a non-destructive test. Therefore the strands were uncovered at three places by stemming the upper surface of the concrete slab.

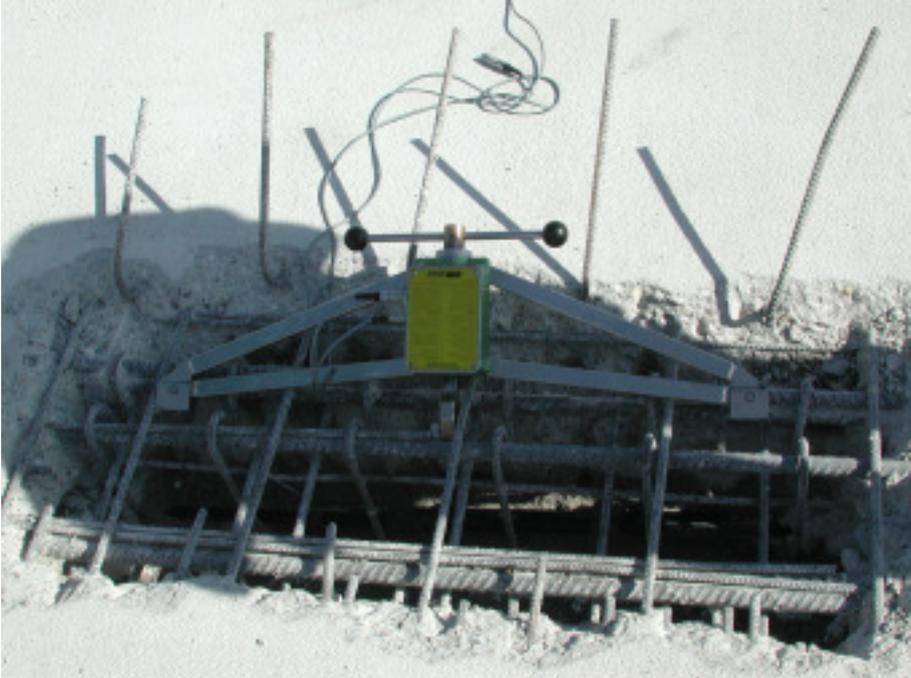
Fig. 5: tensiometer proceq MS 150

- A transversal force was applied to the tendons and the corresponding displacement was measured using a tensiometer procep MS 150 (see Fig. 5). The tensiometer works on the principle shown in fig. 6, but must be calibrated on the diameter of the strand or wire and on additional boundary conditions. The displacement was chosen to reach certain displayed values on the tensiometer of 80, 90, 100 and 110 which correspond to the range of expected prestressing forces according to calibration tests. Four measurements were taken at different positions along each strand in order to minimise the influence of strand twist.

By using the load measuring equipment proceq the transversal displacements of the strands were measured at certain transversal loads. In order to determine the existent prestressing forces a calibration of the results was performed on a reference tendon. Transversal displacements at defined transversal and prestressing loads were measured in those reference tests in a stationary equipment. By comparing these measurement values with those of the concrete member the existent prestressing forces in the concrete slab could be determined.
