ALTERNATIVE METHOD TO PREDICT RESIDUAL SERVICE LIFE OF CONCRETE AIRFIELD PAVEMENT WITH EMPHASIS ON RUNWAYS

H.W. Reinhardt¹, O. Mielich²

¹ *Institute of Construction Materials, University of Stuttgart*

² *Materials Testing Institute (MPA), University of Stuttgart, Otto-Graf-Institute*

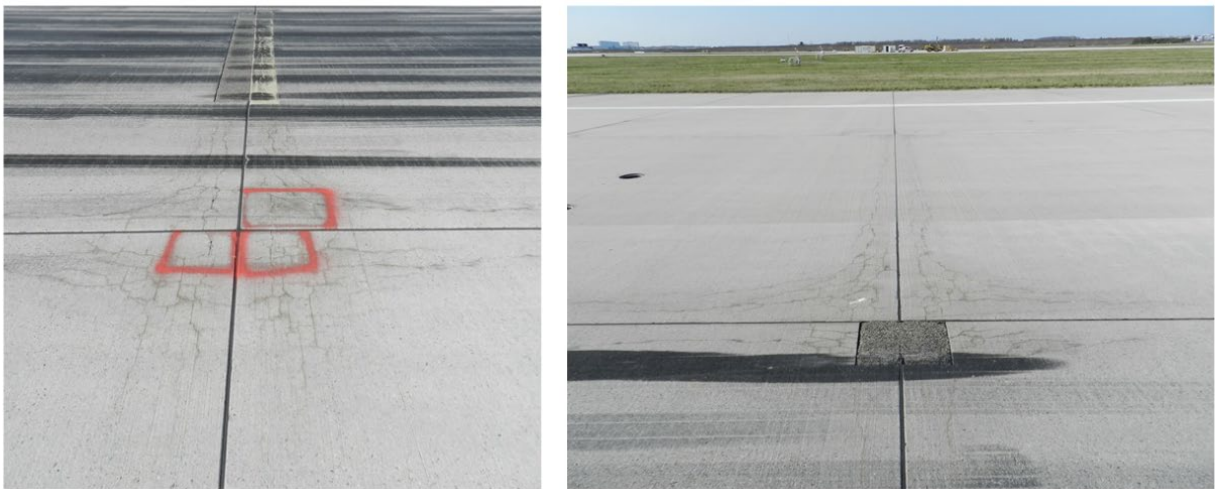
One severe cause of deterioration is the so-called alkali-silica reaction (ASR). The first symptoms of ASR in a concrete pavement are often cracks starting at and running perpendicular to the transverse or longitudinal joints. Map cracking often appears first at the corner of pavement slabs. As ASR advances, the cracks spread around the perimeter of the slabs (Fig. 1).

Fig. 1: Cracking following the perimeter of pavement slabs. Additionally the left figure includes the patching of the transverse joint and the right figure the patching of the corner

No cracking occurs in the center of the slab (Fig. 1, right). The reason that the region around the joints is more prone to cracking is, first, there is often more moisture available at the joints, second, there is less restraint to expansion close to the joint, third, mechanical stresses to vehicular loading are higher at the joints [6]. In many cases, spalling at joints is likely to continue and may require patching. In severe cases, extensive patching can only delay the time until a major repair or replacement is required.

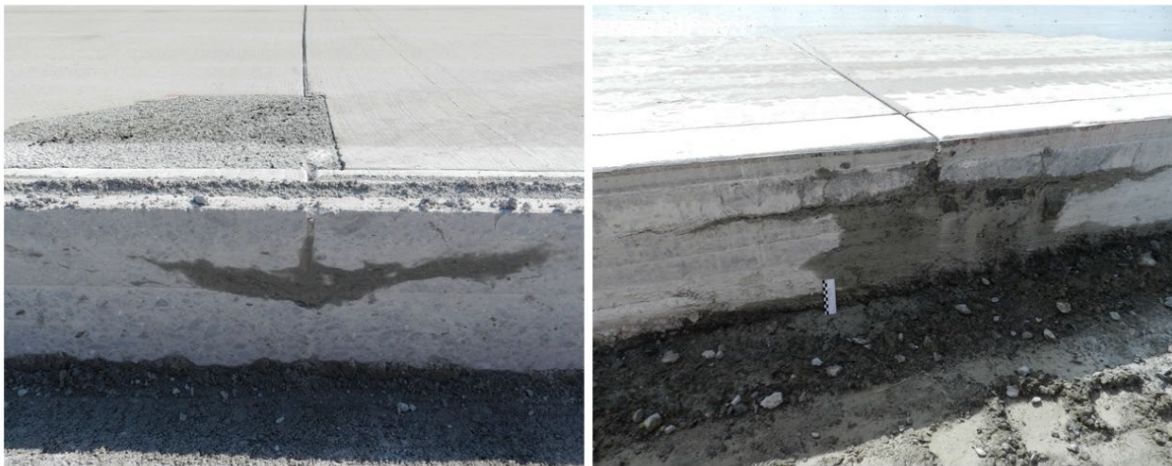
During the inspection of the Portland cement concrete runway of a regional airport, interior cracks parallel to the surface have been found by removal of pavement slabs (Fig. 2 and Fig. 3) and by coring (Fig. 4). It is the sign of delamination.

Fig. 3: Interior cracks parallel to the surface (left and right figure). In the left figure, the interior crack led to a corner crack, which had to be patched

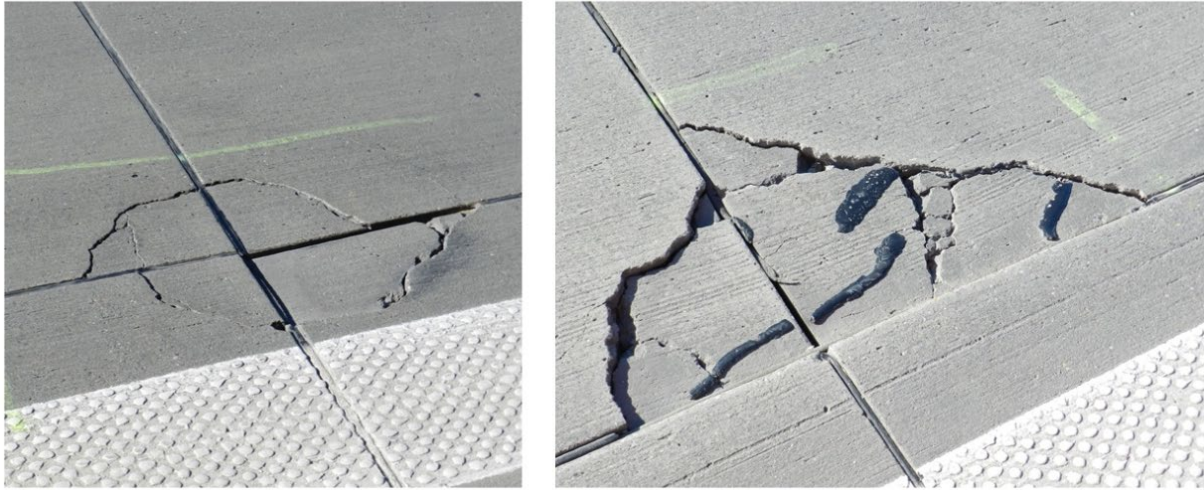
As spoken before, the delamination leads on the surface to diagonal cracks near the corner of a concrete slab may develop, forming a triangle with a longitudinal and transverse joint often (Fig. 5). Usually these cracks are within 20 to 60 cm (approx. 0,66 ft. to 1,97 ft.) of the corner of the slab. With further deterioration, more cracking develops. Eventually the entire broken area may come loose (Fig. 6).

Fig. 6: Further deterioration, more cracking develops (left figure). Broken area may come loose (right figure)
