# HISTORIC CONCRETE – LOOKING AT THE LITTLE THINGS

Benedikt Maurer<sup>1</sup>, Almuth Escher<sup>2</sup>

<sup>1</sup> *Materials Testing Institute (MPA), University of Stuttgart, Otto-Graf-Institute*

<sup>2</sup> *State Office for Monument Preservation Baden-Württemberg*

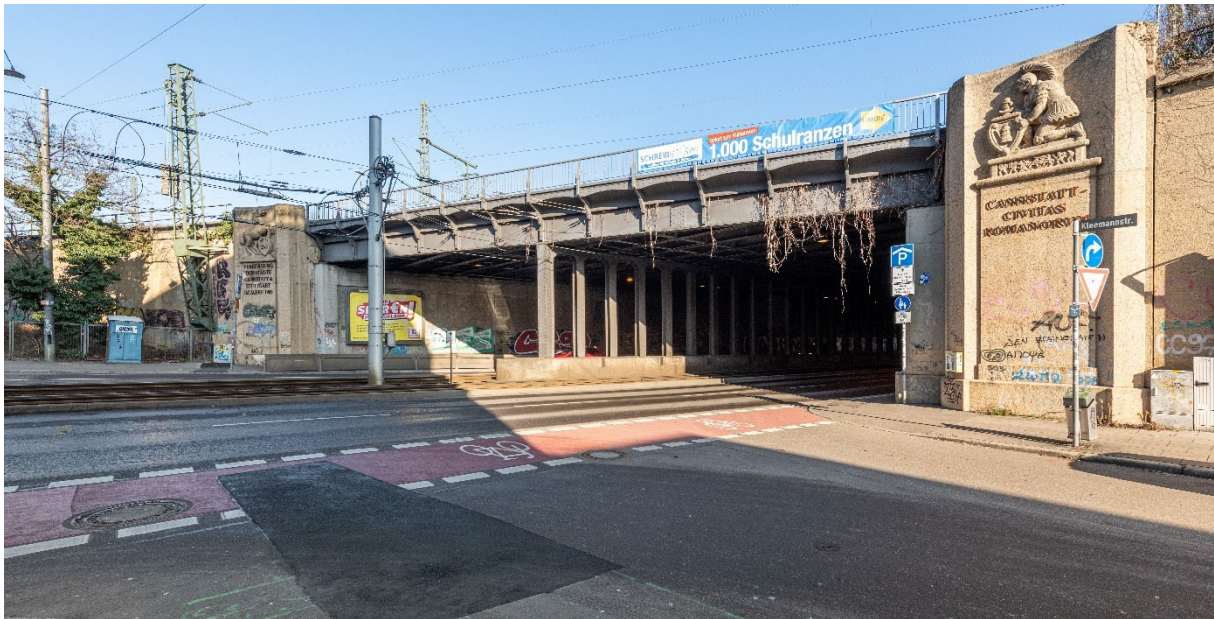
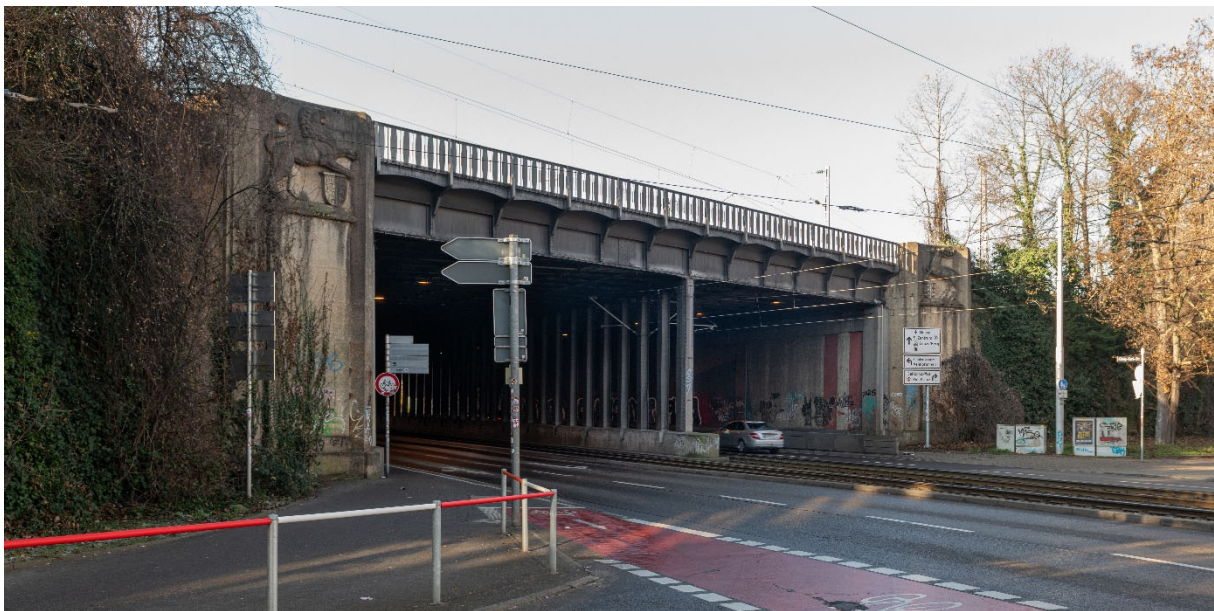
*Fig. 1: Overview of the railway bridge in Bad Cannstatt, Stuttgart. Top: view from Stuttgart, showing the regional abutments of Stuttgart (left) and Bad Cannstatt (right). Bottom: view from Bad Cannstatt. (Source: F. Pilz, LAD)*

The surface of the structure shows typical signs of weather and vegetation induced erosion. The concrete displays small fracture nets along edges and faces, with some parts already breaking of in small chunks revealing deeper concrete layers behind. Further along some cracks show white efflorescence and crustal formations on the concrete. From two specific sites like these the samples for this study have been taken:

The samples analysed in this study originate from the abutment and the adjoining embankment of a railway bridge in Bad Cannstatt, Stuttgart. It was built between 1912 and 1914. The surfaces of the abutments contain ornamental reliefs belonging to the city of Stuttgart and the quartier of Bad Cannstatt. An overview of the site from two directions can be seen in Fig. 1.

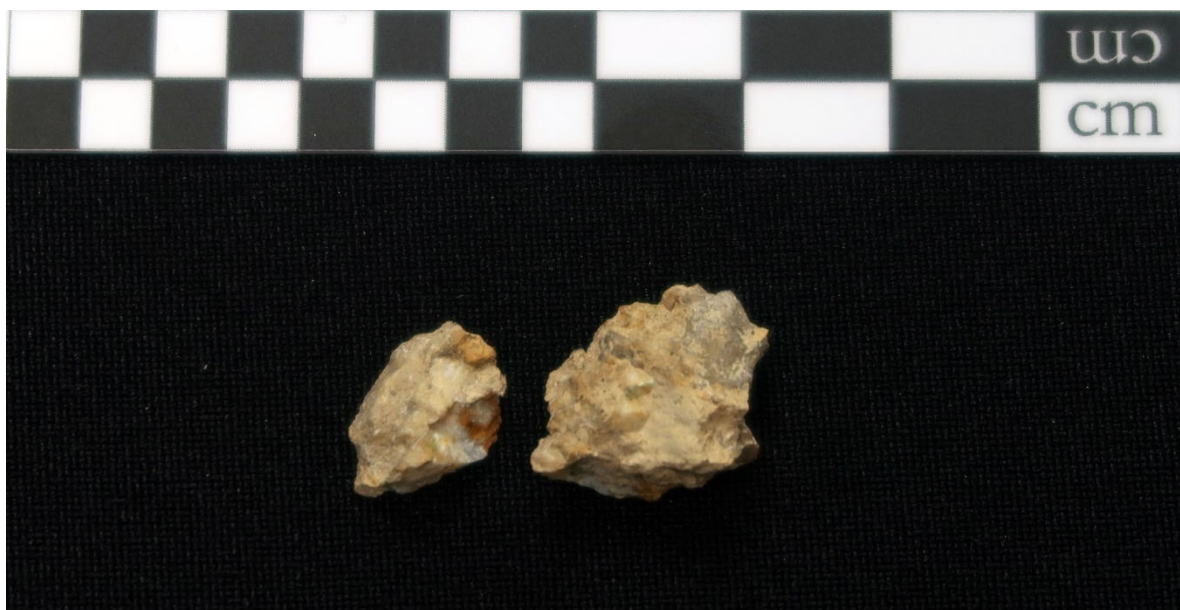
- Two small (ca. 1-1.5 cm in diameter) samples, further denoted as *concrete*, see Fig. 2. They show brittle fracture failure and have been collected in the base area below the right coat of arms (view from Bad Cannstatt), as seen in Fig. 2.

*Fig. 2: Overview of the sample „concrete” showing two beige-brown pebbles*

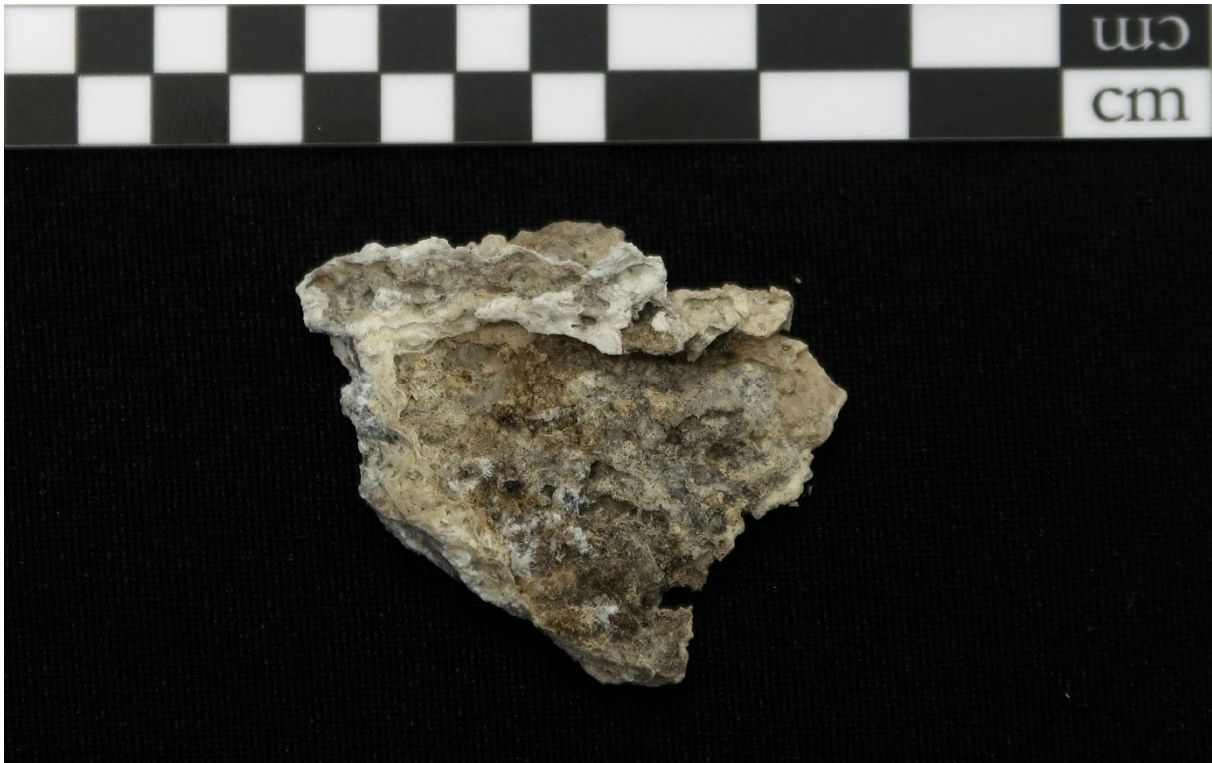
- A sample of white crust, further denoted as sample crust, see Fig. 3. This was taken from the extension of the railroad embankment near the abutment of Stuttgart (viewed from Stuttgart).

*Fig. 3: Backside overview of the sample “crust”. At the top a few white areas are visible, but on the back, green overgrowth of biological colonisation on top of a beige-brown material can be seen*

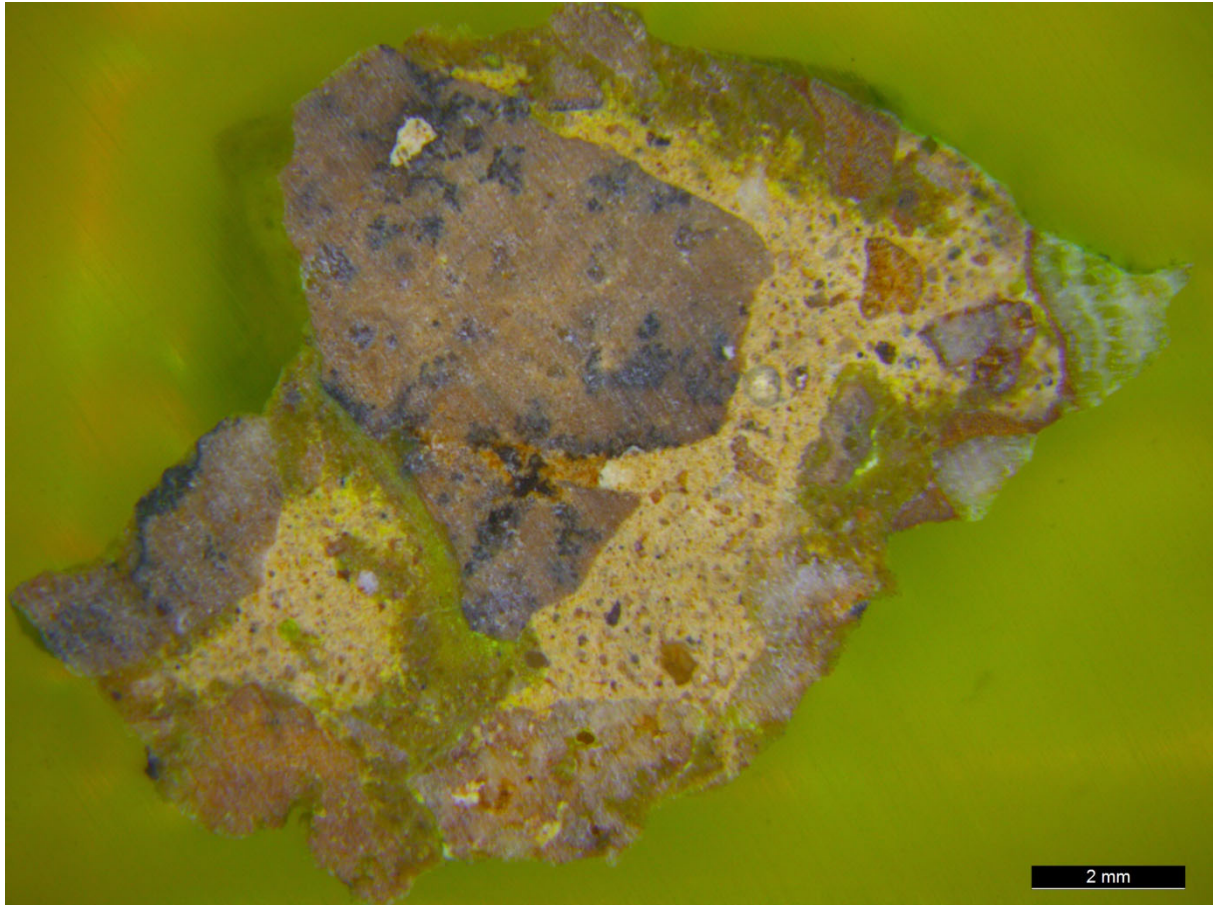
*Fig. 4: Overview of the thick section from the “concrete” sample, embedded in fluorescent epoxy resin. The binding material appears bright, with only small particles inside. There is one large aggregate in the center and more remnants of other aggregates along the sides.*

The thick section of the *concrete* sample can be seen in Fig. 4. The sample size is 15 x 11 mm. It is composed of a large, 6 x 8 mm wide, greyish aggregate in the centre and a beige-coloured binding material and other remnants of aggregates on the sides. Within the binding material, the largest particles appear reddish, with a diameter between 500 to 1000  $\mu\text{m}$ . Most grains, however, are small, less than 200  $\mu\text{m}$  in diameter, mostly with a clear or dark grey appearance.
