THREE REMARKABLE CASES OF STRUCTURAL DAMAGE DUE TO IMPOSED DEFORMATION

Hans W. Reinhardt

Institute of Construction Materials, University of Stuttgart

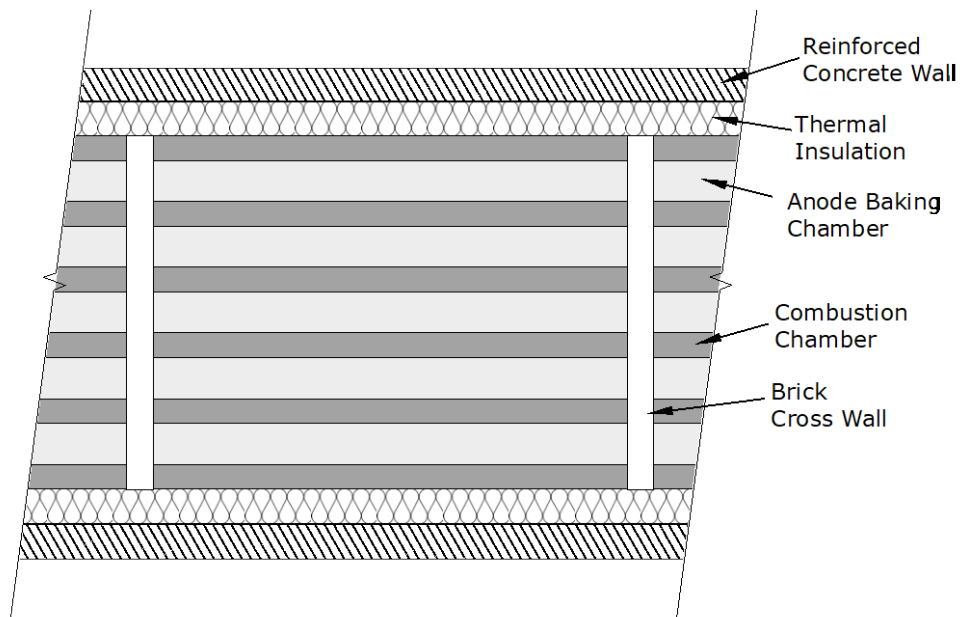
Fig. 3: Horizontal section of the anode baking furnace, schematic, not on scale with reinforced concrete wall, fire-resistant thermal insulation, anode baking chamber, combustion chamber and brick cross-wall (Drawing, courtesy Tilman Reinhardt)

Fig. 3 shows schematically a horizontal section of a furnace which is the core part of the anode production facility. The concrete box contains the combustion chambers and the anode baking chambers (baking shafts) which are arranged side by side and take turns. They run in longitudinal direction.

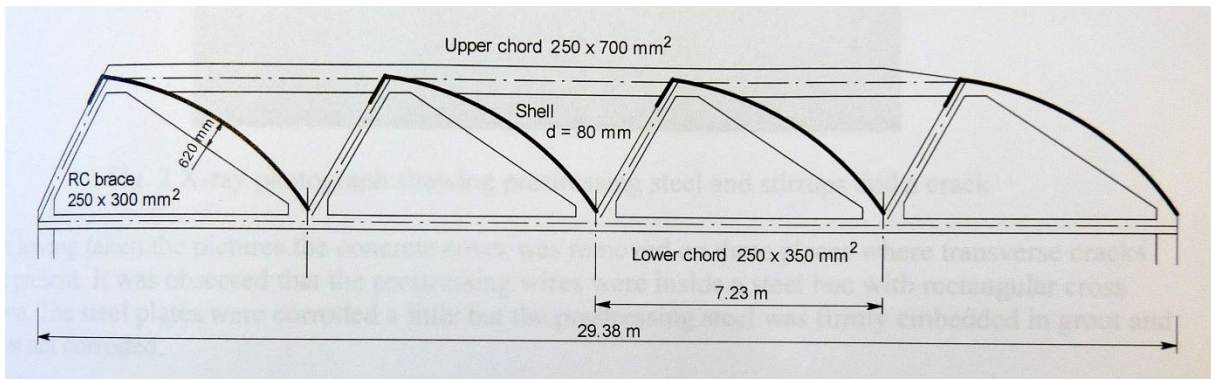
Fig. 7 depicts the statical system of the roof structure. Fig. 8 shows the sheds resting on the trussed girder on which measurements were executed.

Fig. 7: Roof structure (from [5])

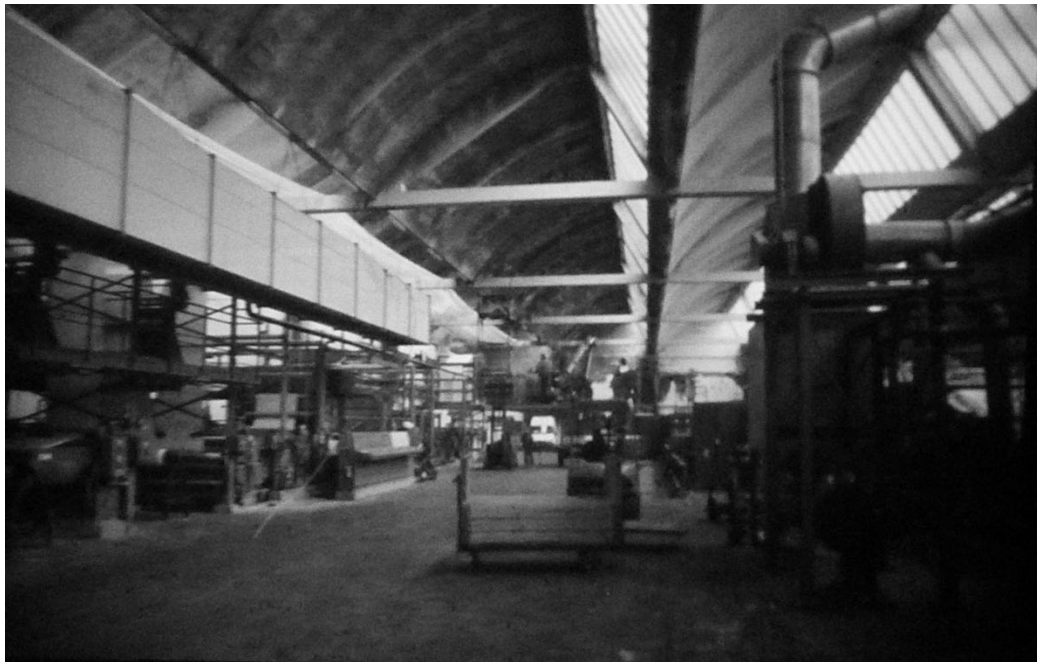
Fig. 8: The sheds resting on the trussed girder
