USE OF ASR DAMAGED CONCRETE PAVEMENTS AS RECYCLED AGGREGATES IN ROAD CONSTRUCTION

Oliver Mielich

Materials Testing Institute (MPA), University of Stuttgart, Otto-Graf-Institute

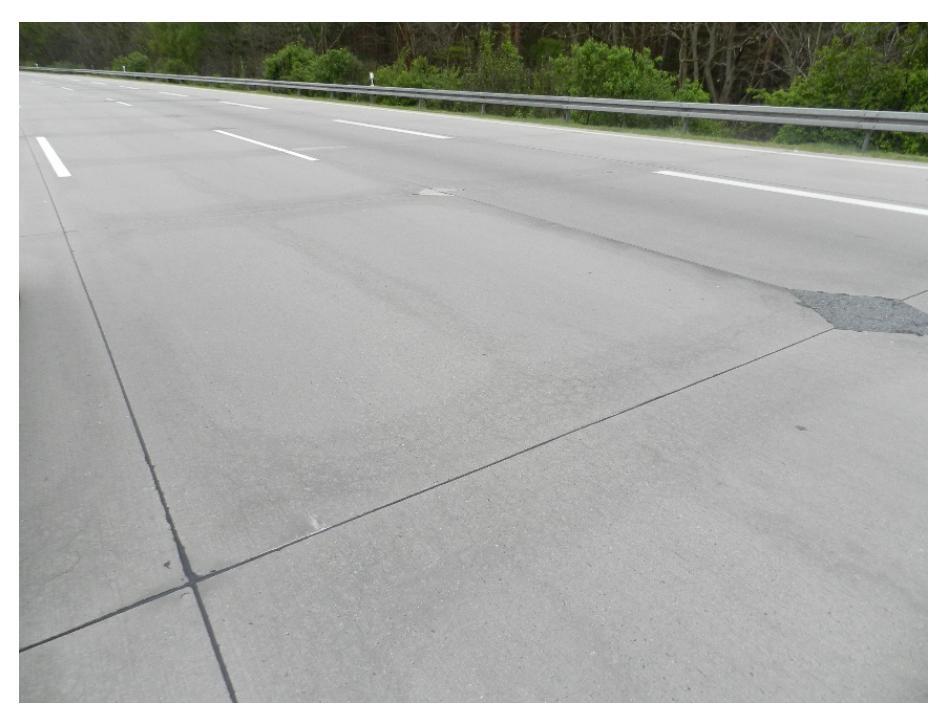
Fig. 1: Pavement surface of a highway associated with ASR (discoloration in the transverse and longitudinal joints, asphalt plombs in the edges)

However, a problem has currently arisen regarding this network of German federal highways. The planned 30-year service life of concrete pavements constructed before 2005/2006 will not be achieved. Aggregates with an ASR sensitivity were used in part for these concrete road pavements. This has resulted in quite pronounced ASR damage today. Obvious signs of damage, usually beginning with discoloration in the transverse and longitudinal joints, corner fractures or longitudinal cracks in the slab, occur after 7 to 15 years [2, 3].

When assessing an ASR-damaged concrete pavement and considering the respective construction, it can be assumed that the old concrete does not necessarily originate from the same old material. Different stiffnesses (E-modules) of the old concrete have to be assumed for ASR-damaged road surfaces which may deviate considerably within one concrete slab. Deviations of up to 50% have been recorded for the elastic modulus [4]. Asphalt plombs (see Fig. 1) and partially large asphalt surfaces from previous maintenance work must also be considered.

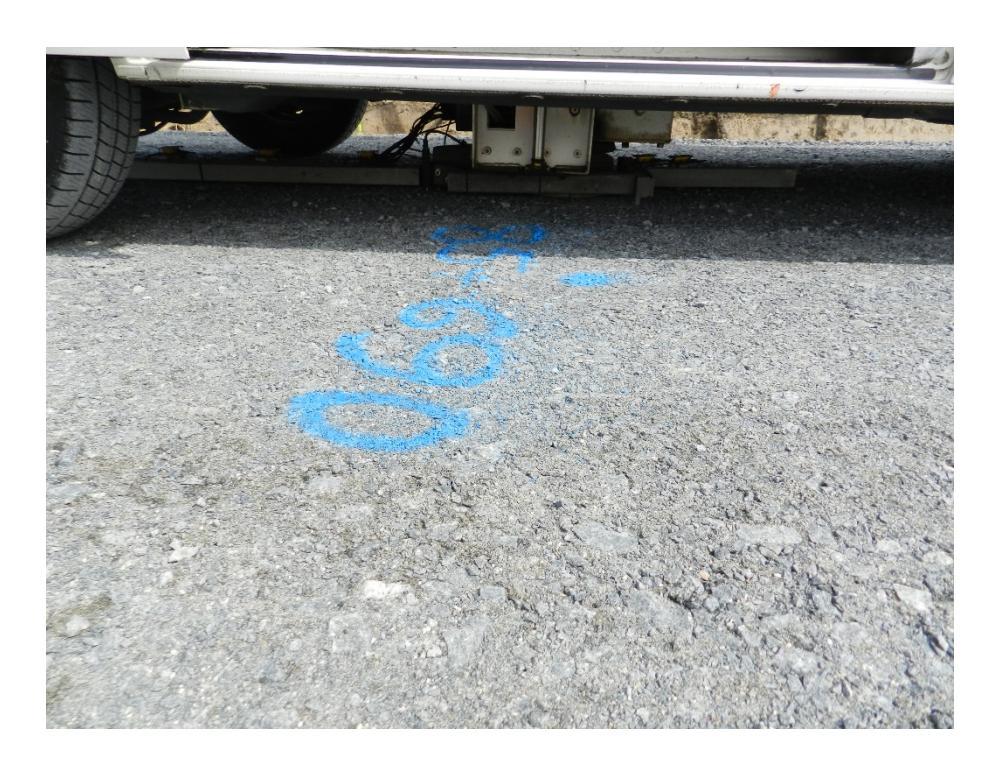
Fig. 2: Determination of the bearing capacity with the Falling Weight Deflectometer (FWD) on the top of an unbound base layer with RC-ASR material

Visual inspection of the surface of base layers applied without binding agents indicate that separation of the RC material cannot be permanently avoided. However, separation was also identified for new construction work in which natural aggregates were applied. Results of bearing capacity measurements with static and dynamic plate load testers on top of crushed-rock layers as well as bearing capacity measurements with the Falling Weight Deflectometer on top of crushed-rock layers (see Fig. 2) and on top of new concrete indicate that consistent bearing capacities in bases without binding agents can also be achieved using RC-ASR material.

In the new federal states, a base layer without binding agents made of recycling material from ASR-damaged road paving concrete was constructed for the first time on a motorway section of the BAB A24 in 1995/96. FWD measurements carried out in 2017 on this section revealed that the good bearing capacity of ToB when constructed led to an increase in bearing capacity after decades of service life. This can be explained by the subsequent hardening potential of RC material. Comparative field tests have shown that RC material had bearing capacity compared to natural aggregates. However, when RC material is used in base layers without binding agents, it can have a negative impact on water permeability. Damage resulting from a change in bearing conditions in the absence of erosion-resistant and frost-proof support, compacting defects or from insufficient drainage in the base were not identified on the motorway section on the A24 with crushedstone base layers of RC-ASR material or on other motorway sections with RC material.

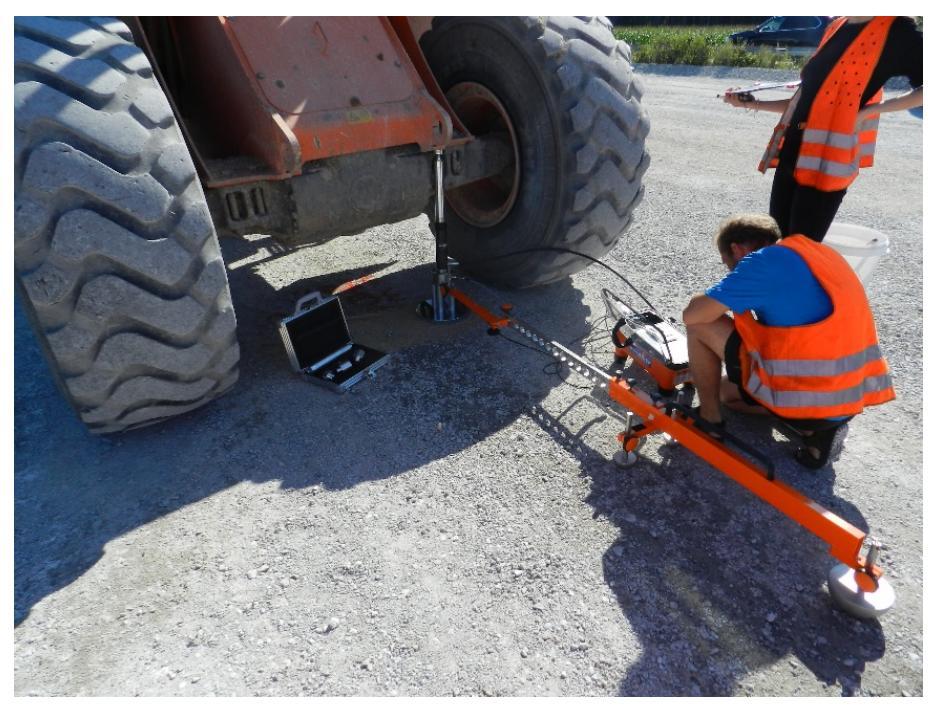
Fig. 3: Plate load test for determination of the E_{V2} and E_{v1} on a surface of an unbound base layer with RC-ASR material

The E_{V2} value of 150 MN/m² required by ZTV SoB-StB 04/07 [14] can be achieved with standard compacting machines. The limit for the ratio value $Ev_2/E_{v1} \le 2.2$ or for $E_{v1} \ge 0.6\% \cdot E_{v2,target}$ (when $E_{v2}/E_{v1} \ge 2.2$) can also be observed. However, problems may arise in fulfilling such requirements if the layers beneath the ToB do not record sufficient bearing capacity values or if the base layer itself is not sufficiently compacted. However, such problems arise irrespective of whether mixes originate from natural aggregate, recycling material of crushed concrete or from ASR-damaged concrete pavements.
