PARTIAL RECONSTRUCTION OF THE RUNWAY AT STUTTGART AIRPORT – QUALITY MANAGEMENT DURING REMOVAL AND CONCRETE PLACEMENT

Christian Öttl

Materials Testing Institute (MPA), University of Stuttgart, Otto-Graf-Institute

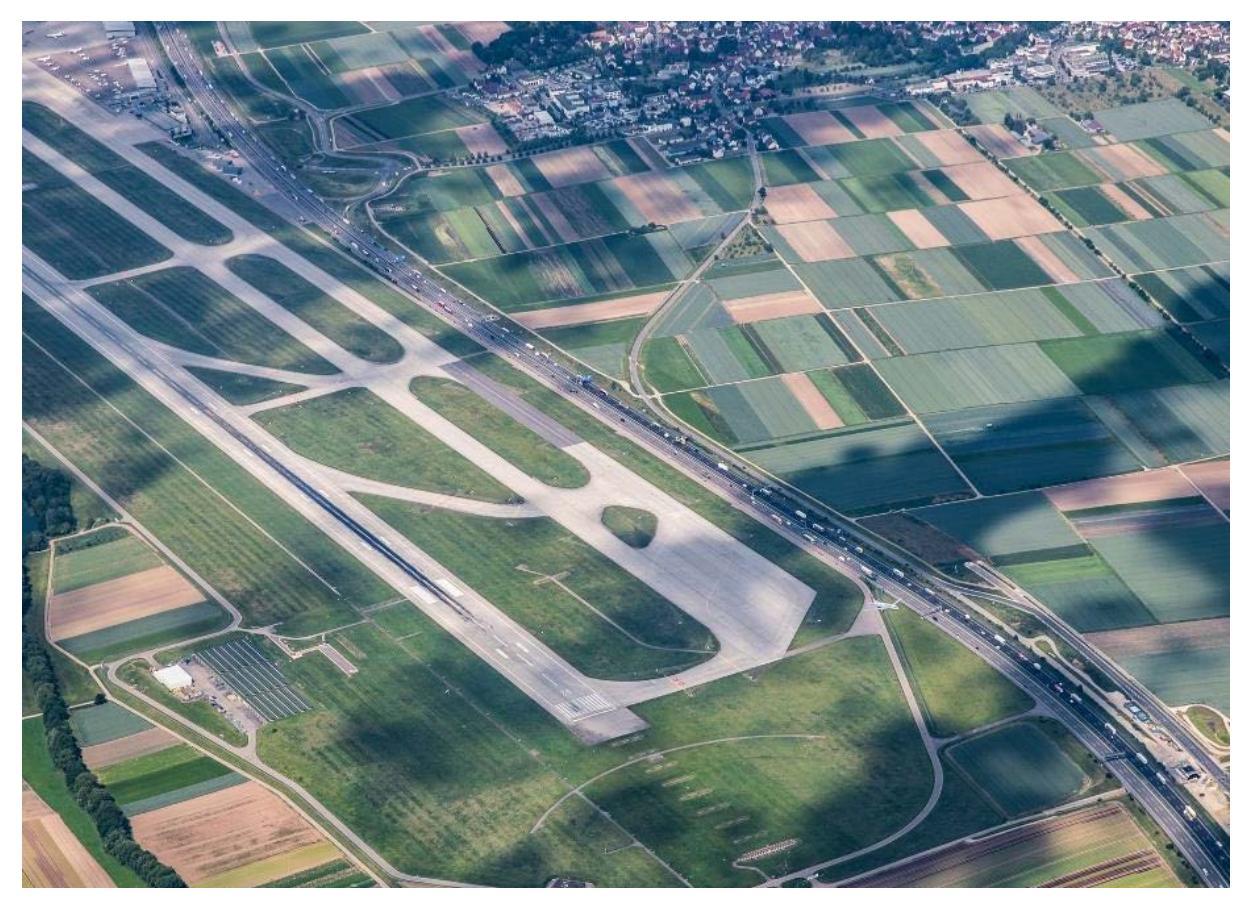
Fig. 1: Aerial photo of the eastern part of the runway at Stuttgart Airport (source: Flughafen Stuttgart GmbH)

A partial reconstruction of the runway at Stuttgart Airport was undertaken in spring 2020. Thereby, the 1,200 m long eastern part of the 3,345 m long runway was replaced. The majority of the planes landing in Stuttgart use the eastern portion of the runway (Fig. 1). Such extensive use of the concrete runway built in the nineties of the last century resulted in ever increasing maintenance costs, finally rendering the reconstruction necessary. The present paper discusses some particular aspects of the reconstruction from the concrete technology standpoint and presents an overview of the quality assurance measures necessary for achieving a sufficiently strong and durable concrete pavement.

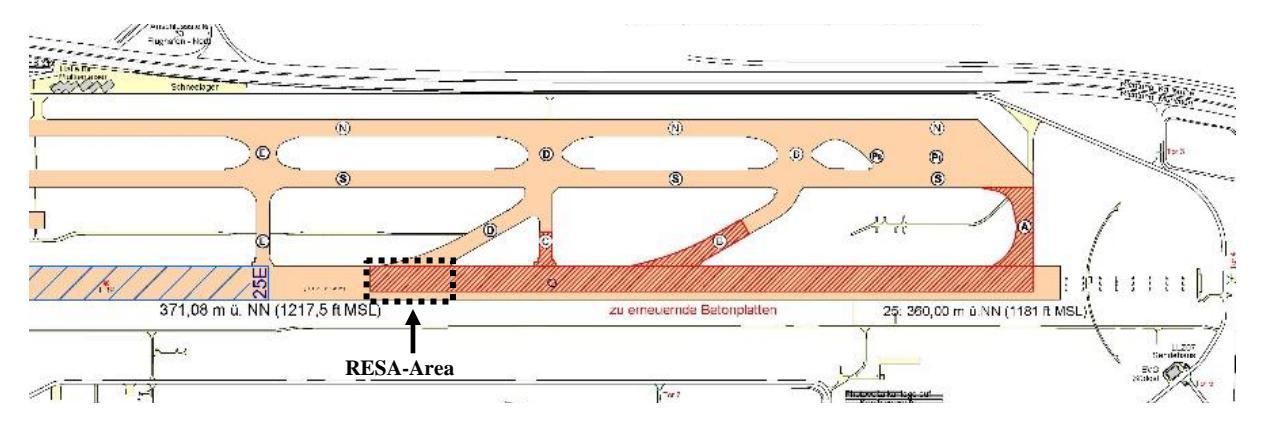
Fig. 2: Reconstructed area (hatched) with RESA-Area (Source: Flughafen Stuttgart GmbH)

Only 28 days were available for each of the two construction phases, which resulted in increased time pressure already from the beginning of the reconstruction. Particularly at the transition from the construction site to the existing building - in the so-called RESA area (Runway End Safety Area) - there was a very tight schedule because no work was permitted in this area under air traffic. Consequently, in the 120 m long RESA area (Fig. 2), construction work was only possible at night between 10 p.m. and 5:30 a.m. Furthermore, neither positive hindrances (elevations) nor negative obstacles (depressions) were allowed in the RESA area during flight operations, which means that all areas that were removed during one night must be concreted again the same night.

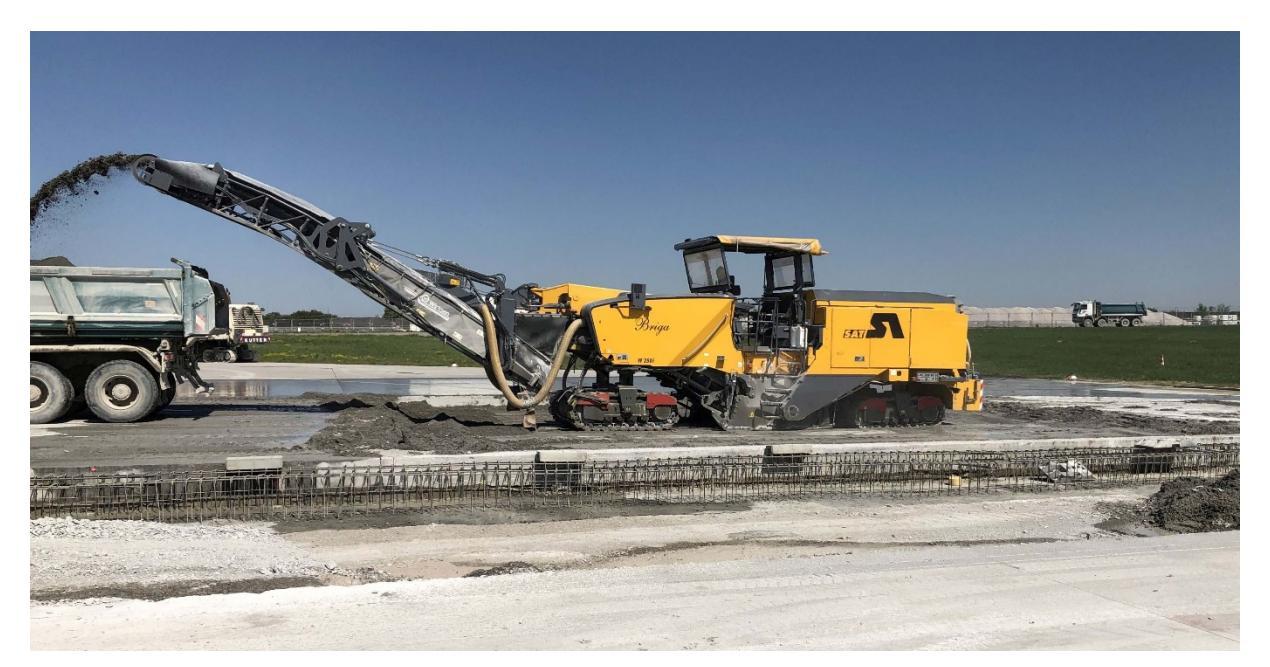
Fig. 3: Milling machine for removing the 40 cm thick concrete slabs

The removal of the 40 cm thick concrete pavement slab was performed in several milling phases (Fig. 3). In order not to damage the hydraulically bound base layer below, the initial coarse milling passes were followed by a fine milling pass. The microstructure of the exposed surface of the base layer was then evaluated and, in cases of doubt, the load-bearing capacity was checked using a static plate load test (Fig. 4). After the surface had been released for concreting, metal baskets with plastic-coated dowels were positioned on the base layer.

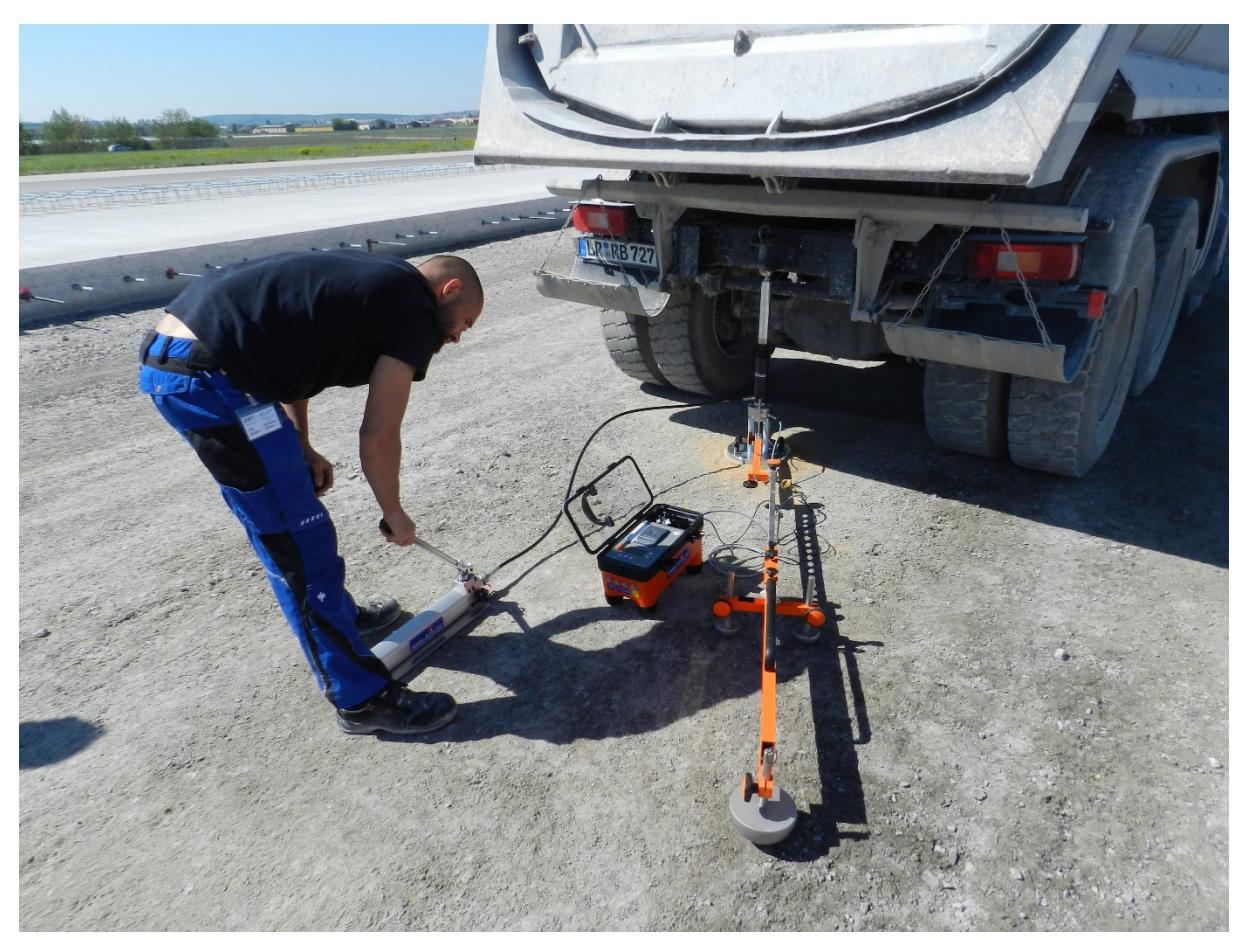
Fig. 4: Measurement of the load-bearing capacity of the hydraulically bound base layer

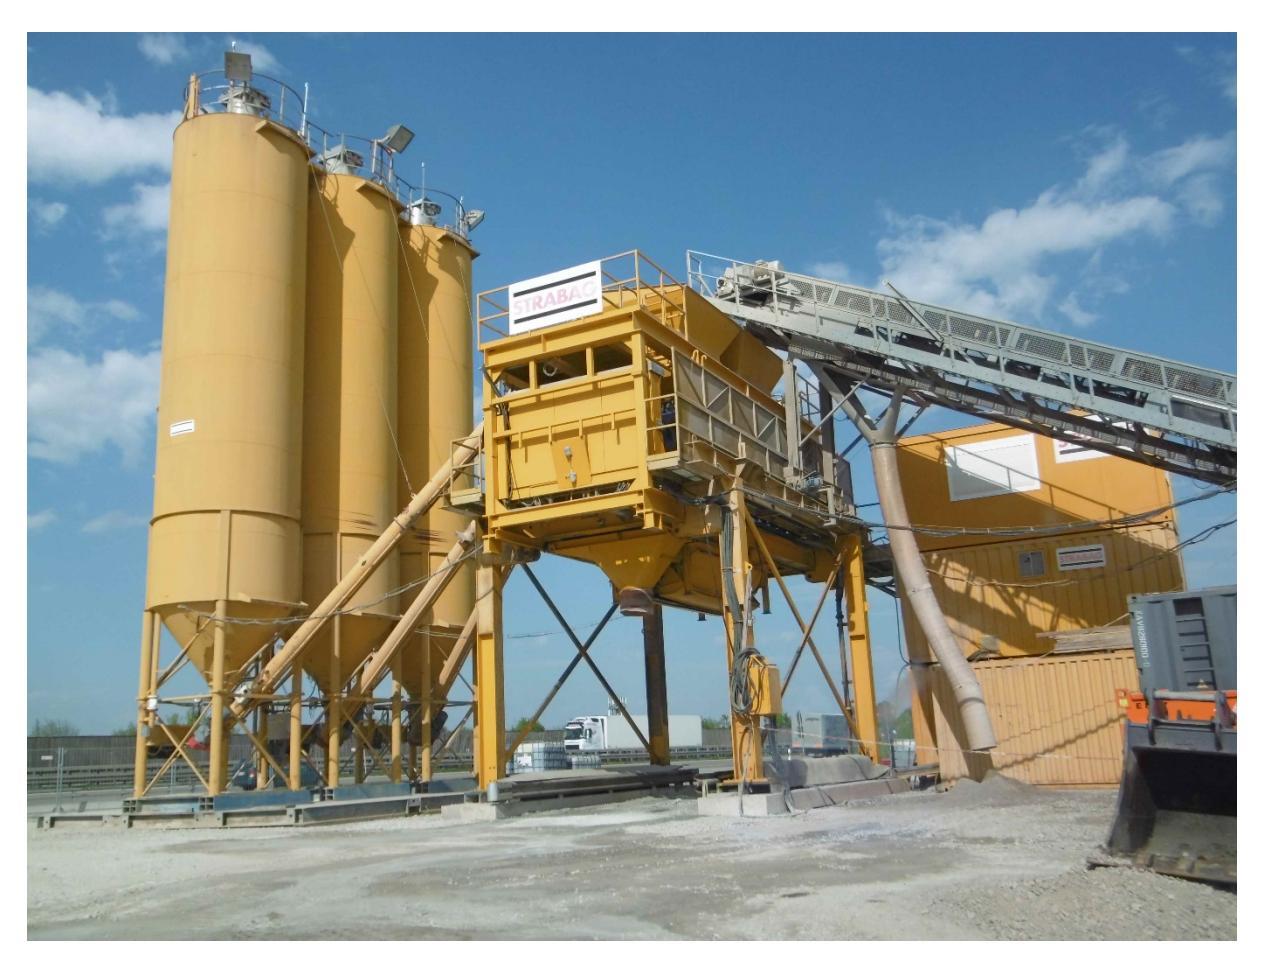
Fig. 5: Mobile batch mixing plant for the paver concrete and manually placed concrete

The concrete production was carried out on site with a mobile batch mixer type "BHS Duomix 300" (Fig. 5) and a mobile continuous mixer type "BHS Modulmix 200/3" (Fig. 6). In order to ensure a constant concrete quality, the continuous mixer was used for the production of the paver concrete only, while the batch mixer was used for mixing the concrete placed using the paver and for the manually placed concrete.

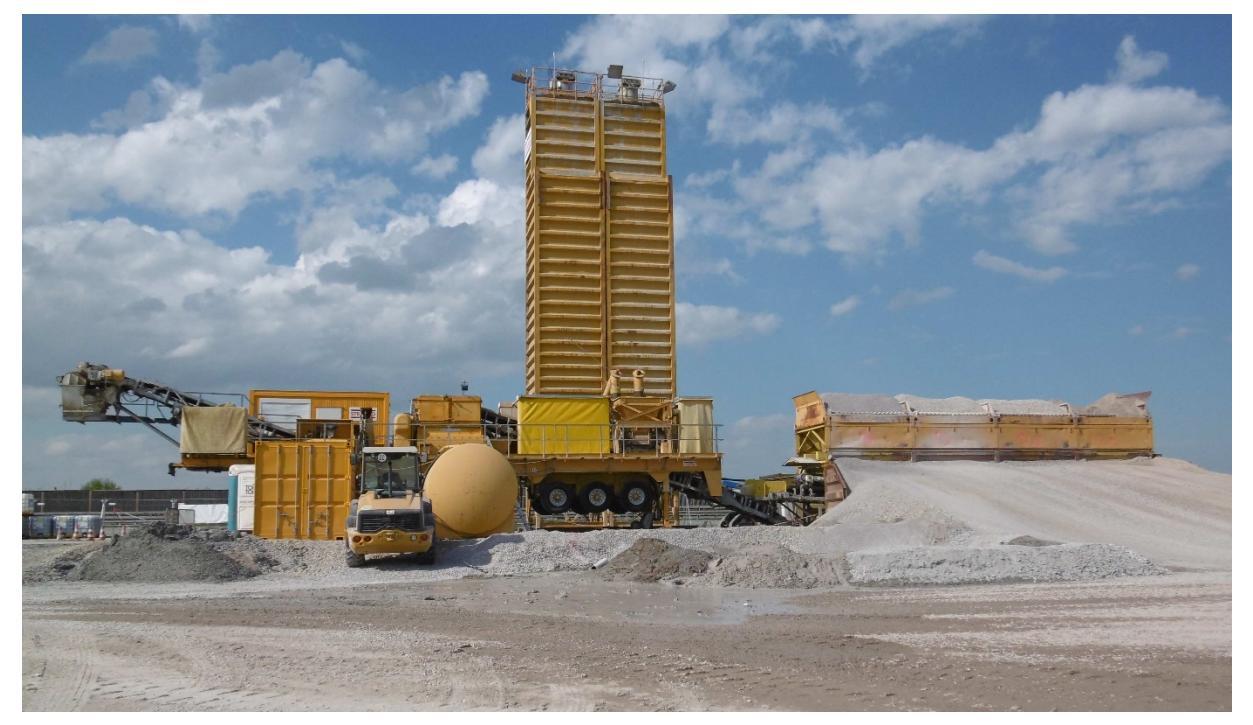
Fig. 6: Mobile continuous mixer type for the paver concrete

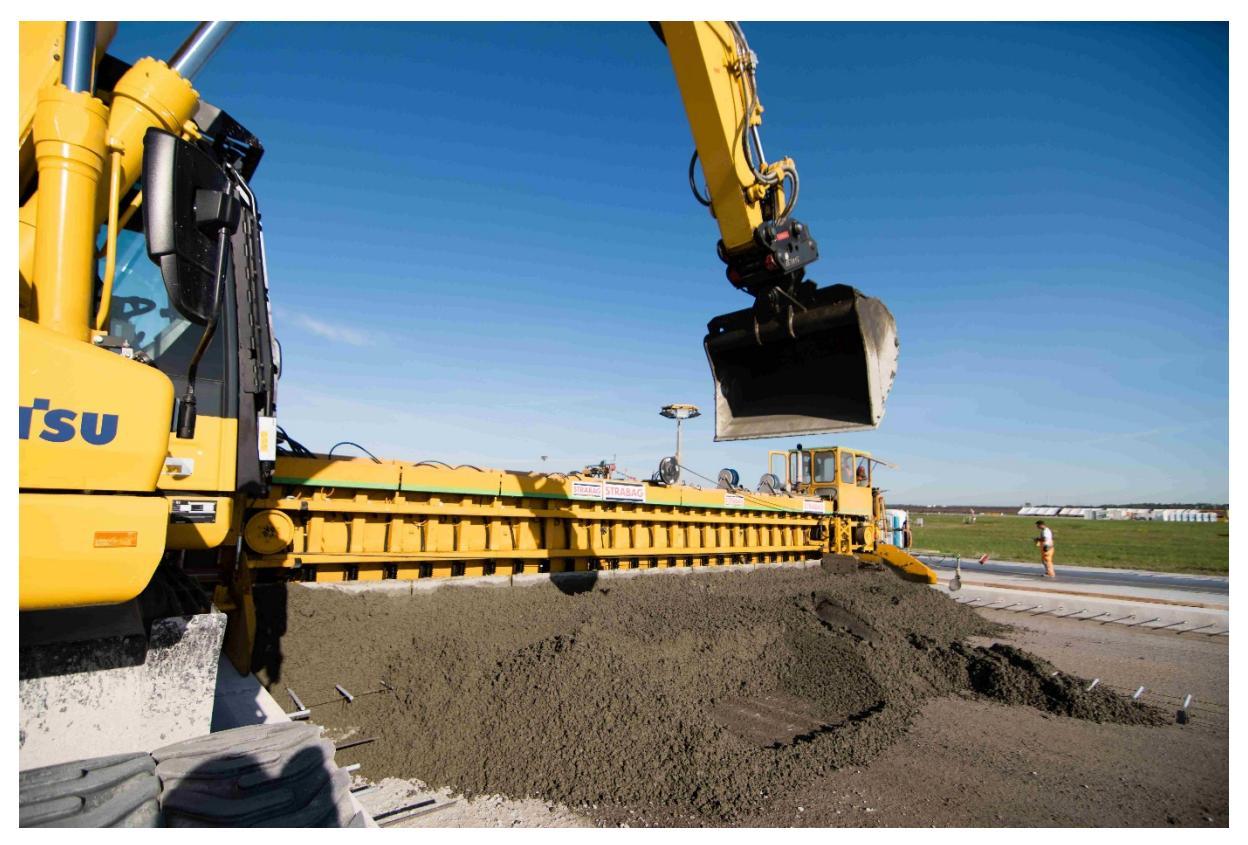
Fig. 7: Slipform paver. Distribution of concrete with an excavator

The concrete was placed in one single layer in the previously milled strips between the existing tracks. The concrete, which had been transported with dump trucks, was first distributed by the excavator (Fig. 7). After spreading with the spreading plough, the concrete was compacted in the grout box in front of the slipform paver using vibrating rods. The compaction beam was used to level the concrete to the paving height specified by the side strips. The subsequent finishing beam, in conjunction with the super smoother, ensured the surface finish and final evenness (Fig. 8). From the trailing working platform, the broom finish was applied with a steel broom to improve the initial grip and the liquid curing compound was applied to the pavement surface.

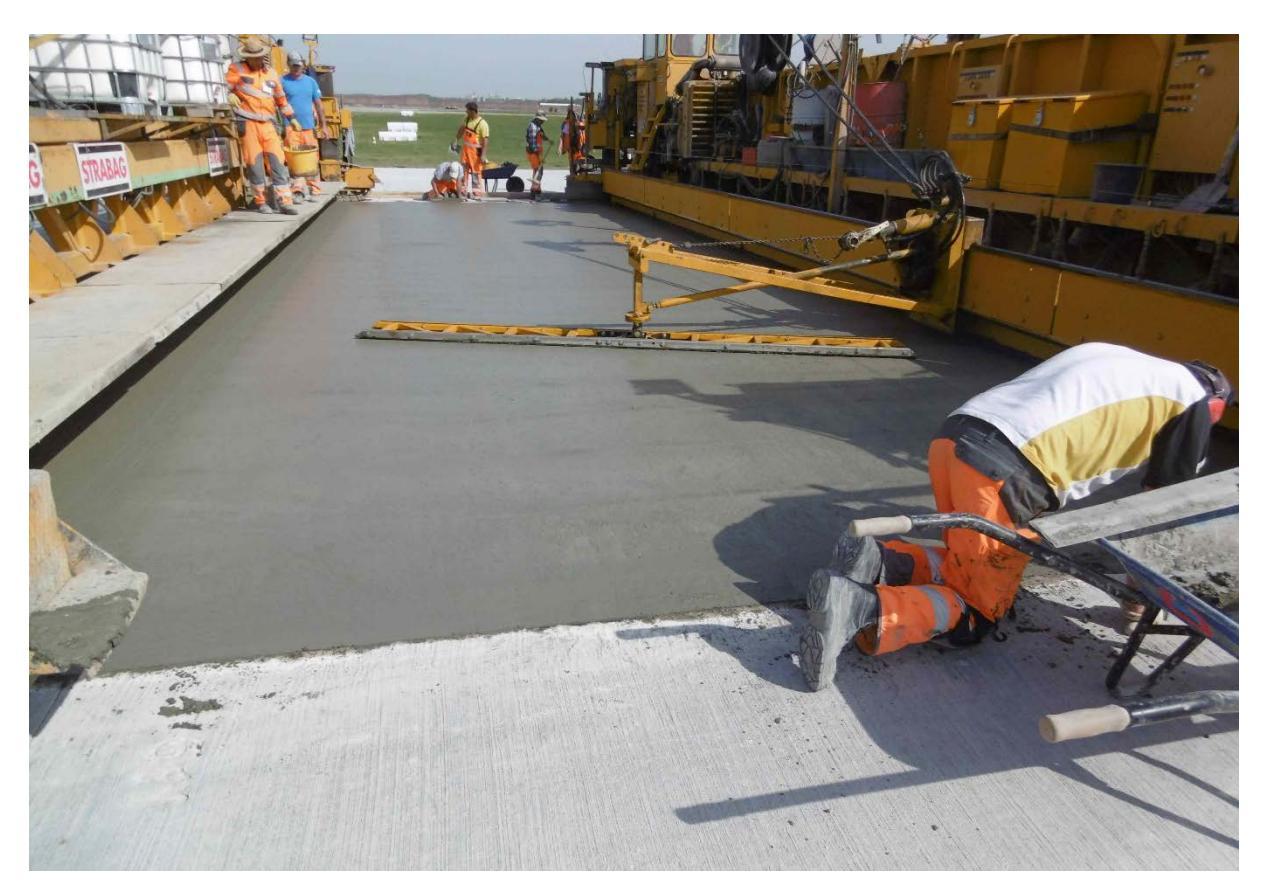
Fig. 8: Finishing beam and super smoother for the finishing of the pavement. Trailing working platform used for the application of the broom finish

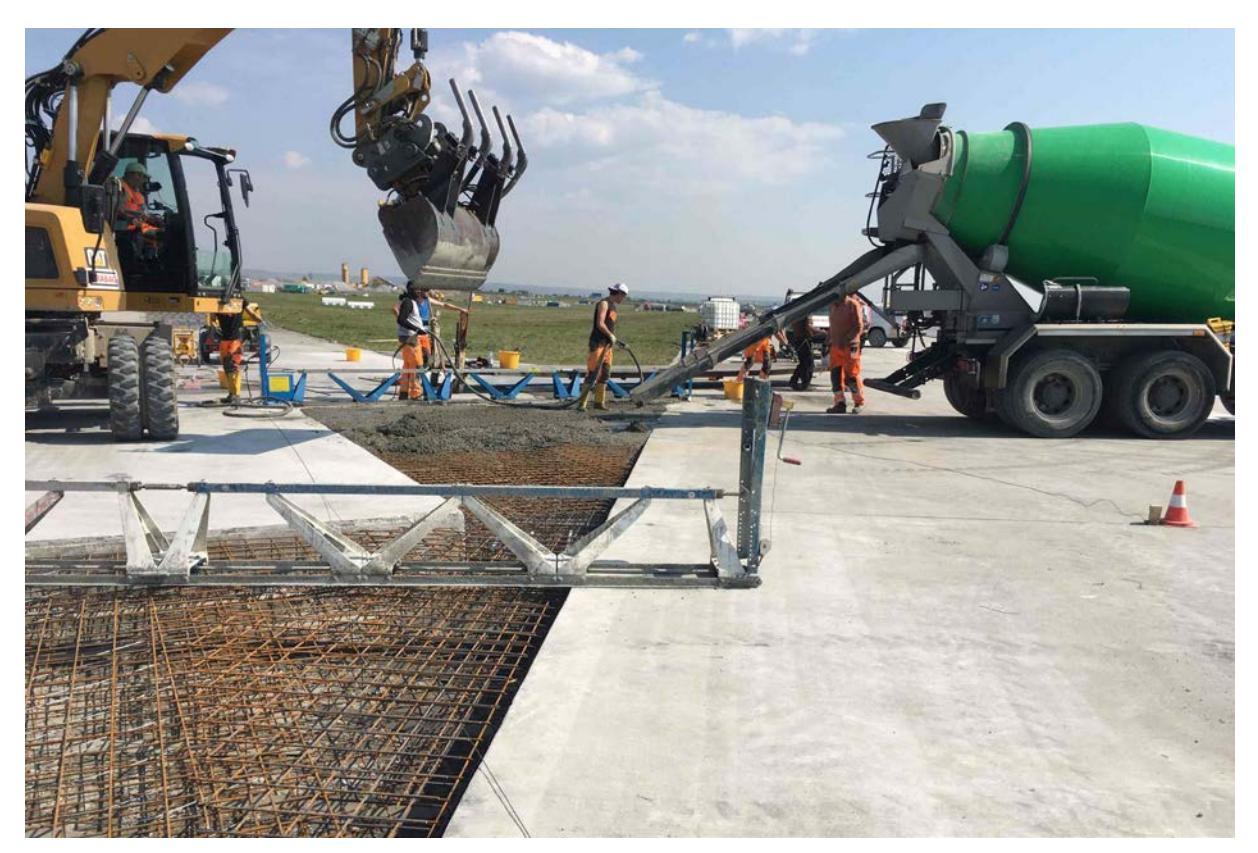
Fig. 9: Manual concrete placement

The concrete was placed in single layers in small, partially reinforced individual fields. The concrete, delivered by truck mixers, was delivered directly to the paving site via the discharge chute (Fig. 9). After distribution with an excavator, the concrete was compacted using vibrators. A vibratory truss screed guided at the edges was used for surface finishing. After the broom finish was produced, curing agent was applied.

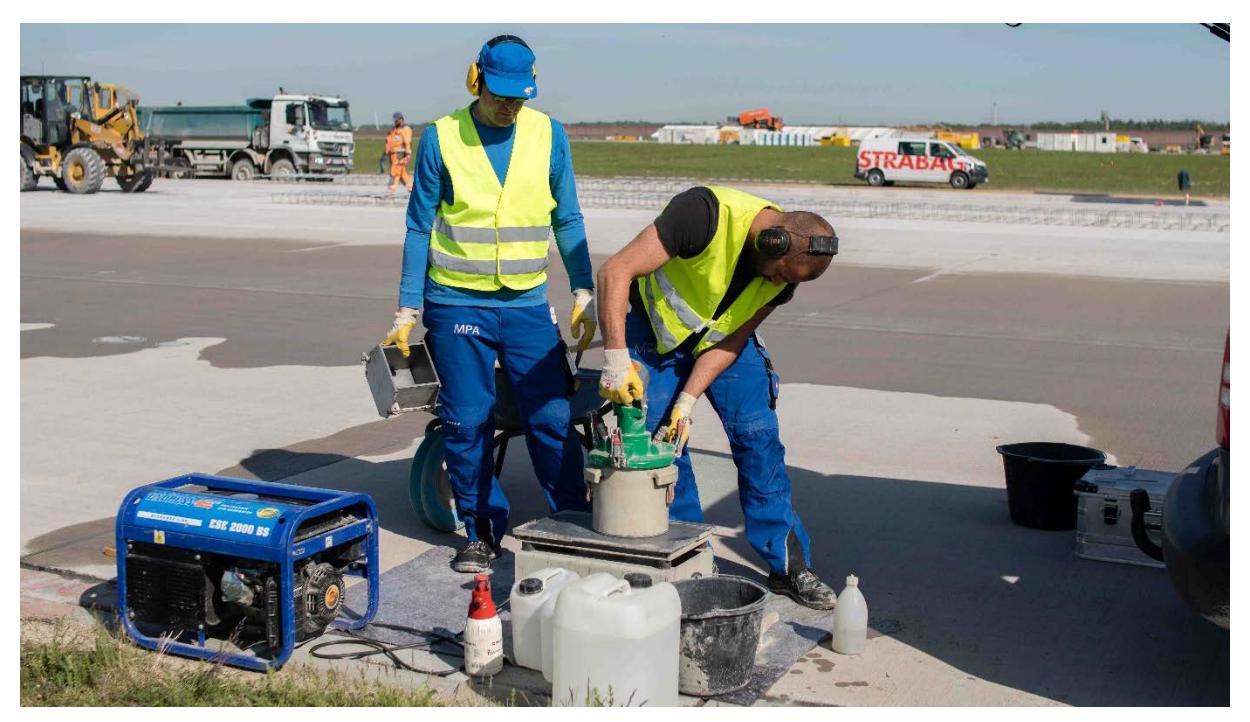
Fig. 10: Acceptance testing at the paving site

The quality assurance of the concrete was based on the requirements from [1] and [2], consisting of initial type testing, contractor testing and acceptance testing (Fig. 10). The test procedures, test frequencies and responsibilities contained therein were concretized and partly supplemented in a quality assurance plan to meet the special requirements of the present construction project. Among other things, the quality assurance plan described that so-called test mixes are to be carried out after presentation of the initial test results and after installation of the two mixing plants. The timeline was laid out so that, if necessary, potential problems could be addressed before the construction began. In order to establish

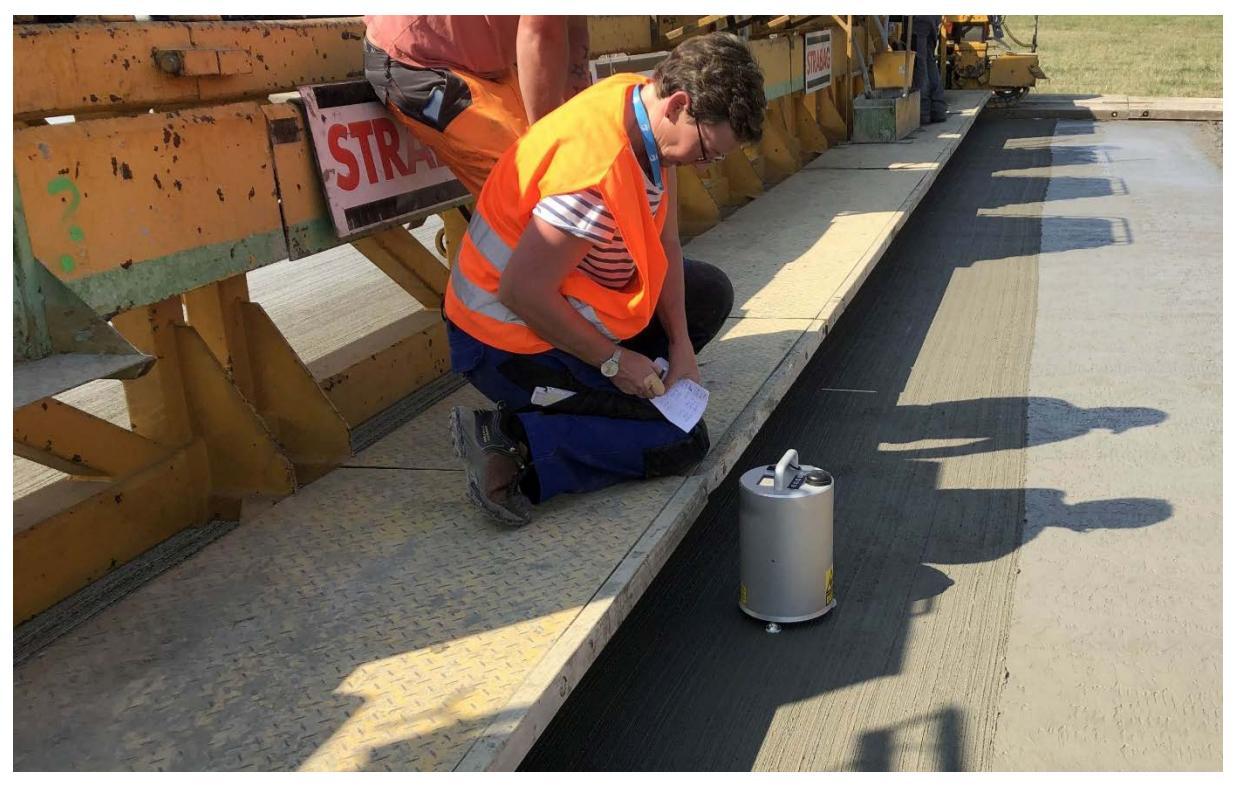
Fig. 11: Measurement on the concrete surface with a laser-based texture depth meter

confidence in the results of the contractor testing and acceptance testing, the tests on the test mixes were carried out simultaneously. In addition to the usual acceptance testing, further properties were measured during the construction work, such as the measurement of the texture depth on the concrete surface with a laserbased texture depth meter (Fig. 11).
